Onsite Inspections Ltd Property

Property Address	1 Sample Way
Photo Of Dwelling

Inspection Details

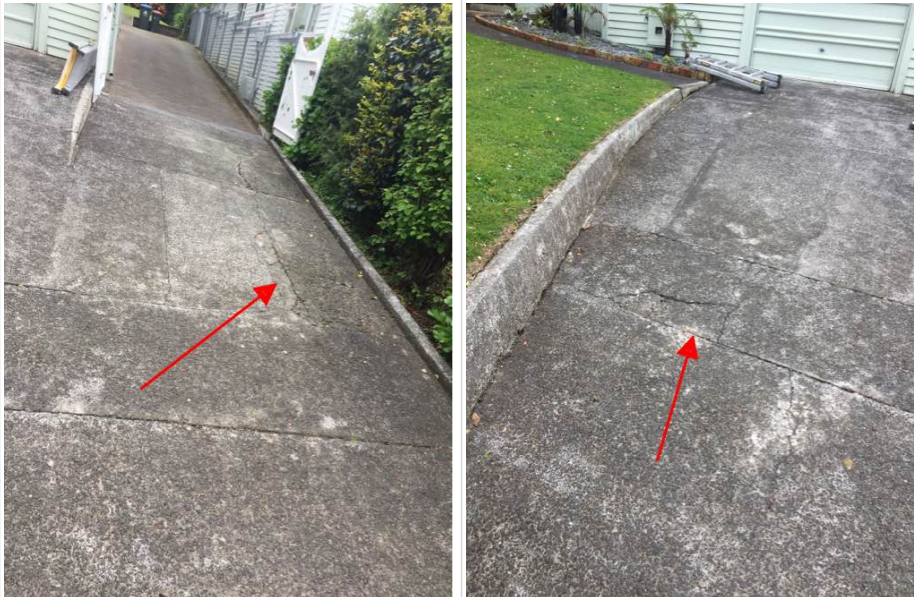
<p>Some cracking</p> <p>Evidence of some cracking and possibly a previous repair.</p>

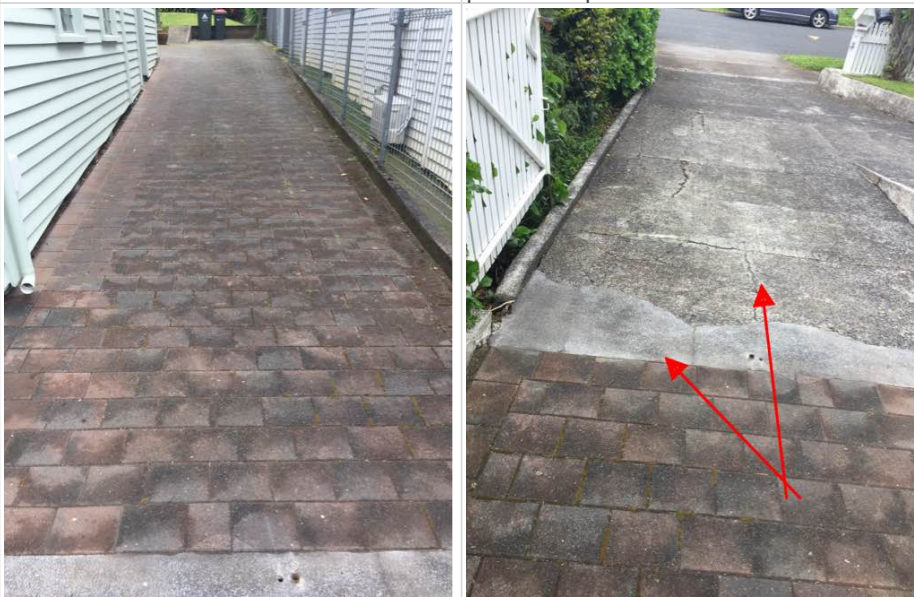
<p>Cobbles in good condition</p> <p>Some cracking and small repair</p>
Adequate Drainage to Driveway and Patios	Yes

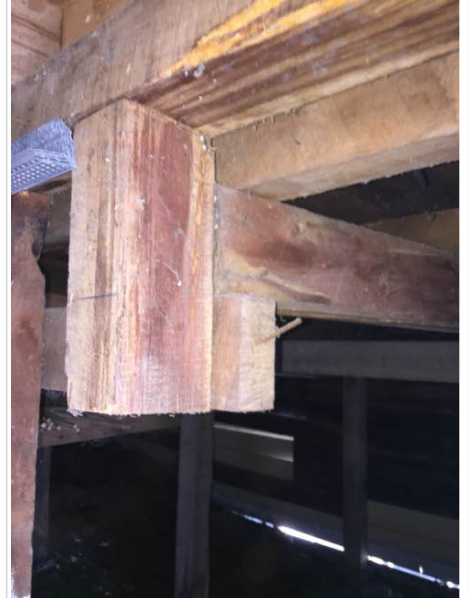
Appears a stud may have been cut to gain access under house. This area requires attention.

There are a couple of areas which require remediation as outlined in the subfloor section. Recommend an LBP to add additional beams and supports where required.

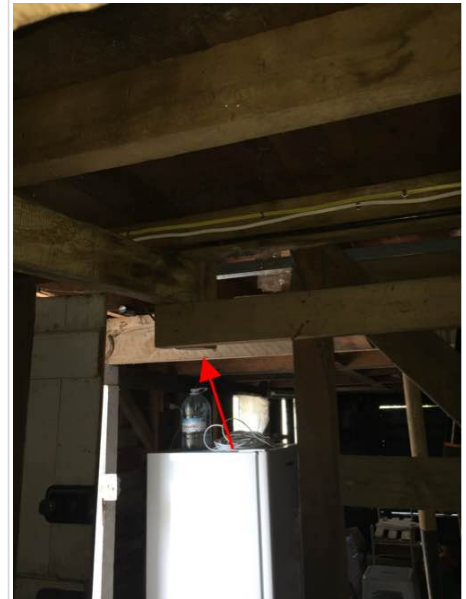
4x2 canitlevered stringer holding up a bearer over the extension

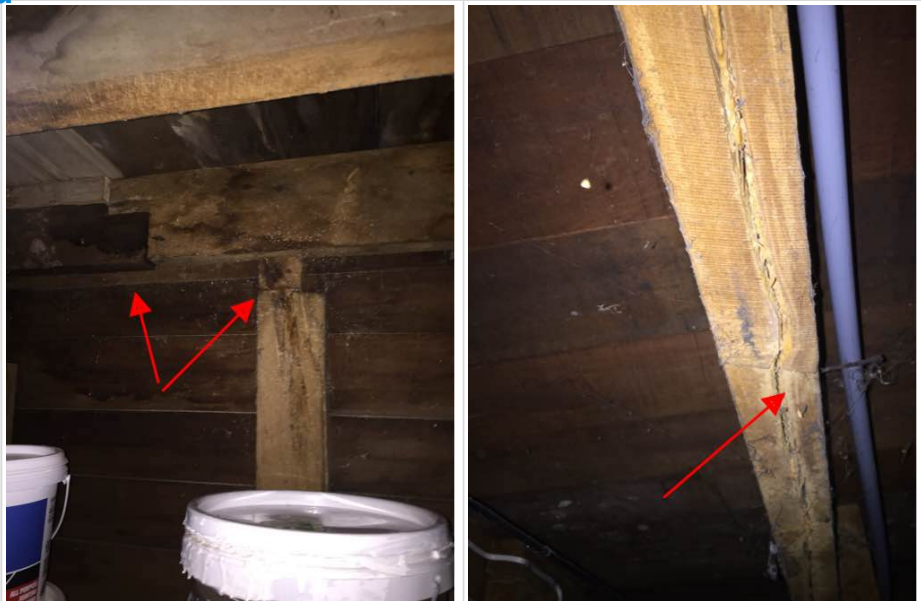
Packer under joist. No support under join.
 No mechanical fixings. requires attention.

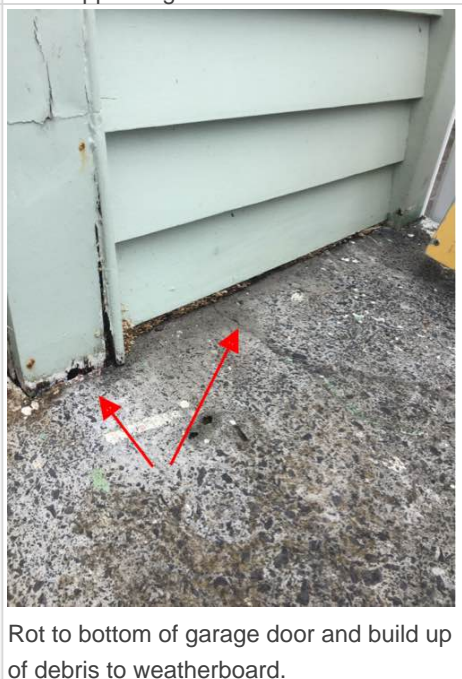
<p>Rot to bottom of garage door and build up of debris to weatherboard.</p>	<p>Rot to bottom of garage door facing.</p>

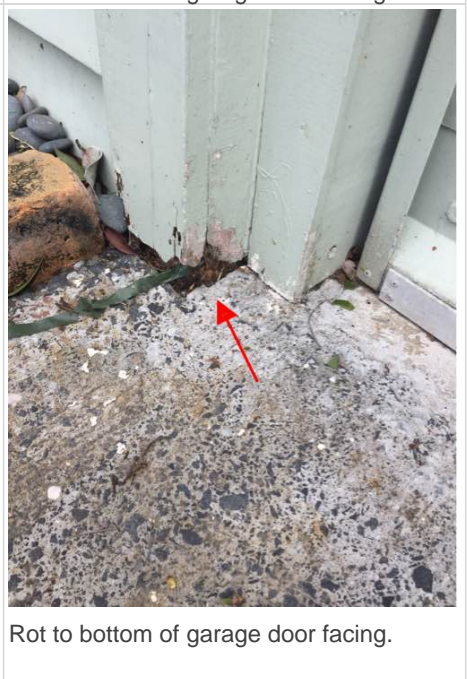
<p>Rot to bottom of garage door facing.</p>

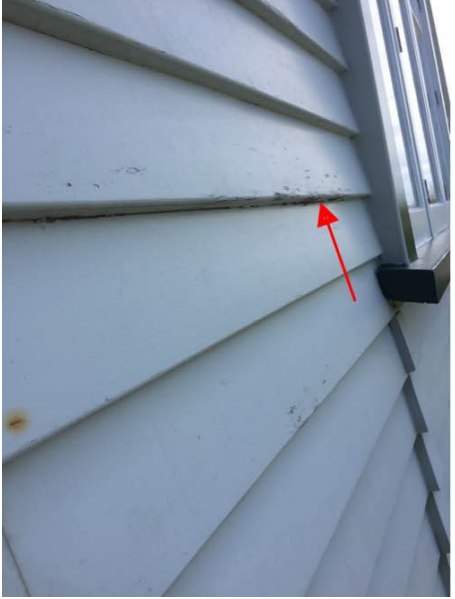
<p>Cladding in contact with ground.</p>	<p>Paint peeling off in small section to front of house.</p>

High ground levels and cladding being in contact with the ground are known causes for timber rotting. Ongoing maintenance is recommended to ensure there is no build up of debris, as this can trap moisture.

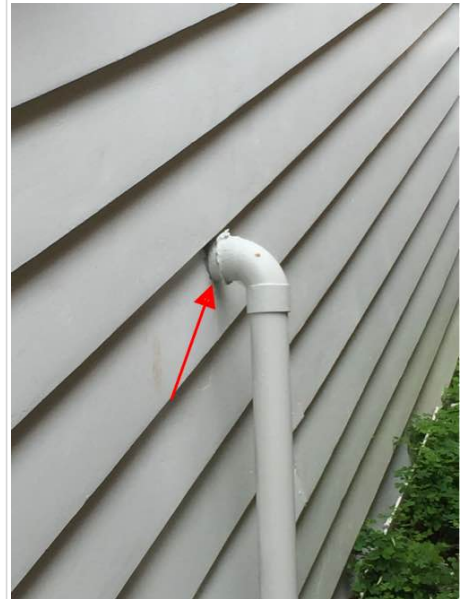
Penetration not sealed correctly.

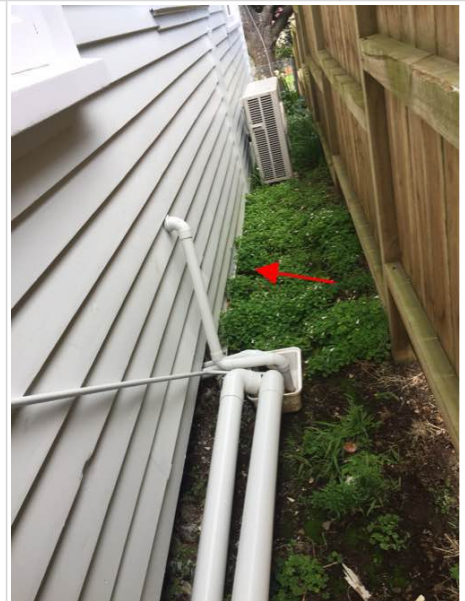
Ground and vegetation in contact with cladding. Maintenance required.

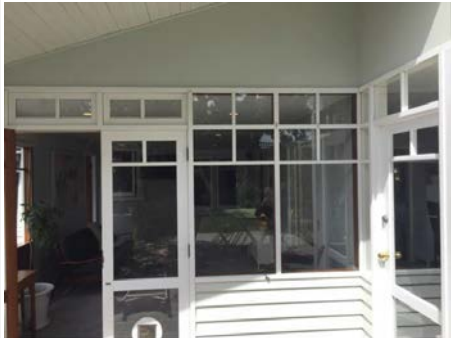
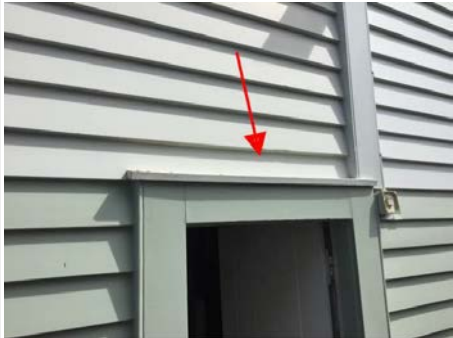
<p>Joinery in good contouring</p> <p>No head flashing to door under house. Maintenance required to ensure sealant does not crack and allow water to penetrate.</p>

Both Garage doors do not have head flashings. Seeing as this is below floor level, it is not a cause for concern, however it is recommended that they are sealed with an outdoor silicone and regularly checked to help stop water ingress.

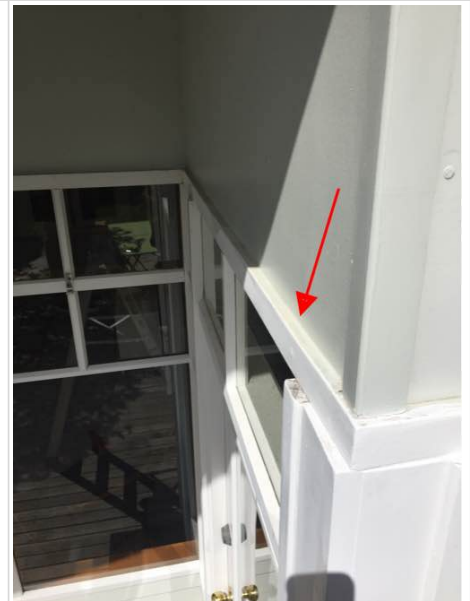
No head flashing

The windows to the rear of the house (lounge, office, children's play room) do not have head flashings. The lounge and children's play room have cover from the soffit overhangs and are of less of a risk, however it is recommended that these areas are constantly monitored to ensure the sealant does not deteriorate and allow water inside, especially to the office.

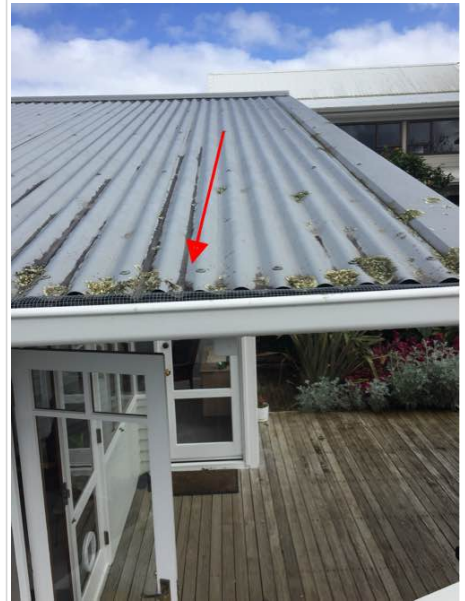
Lichen and Moss

The roof is in good condition with some sheets being replaced. Recommend moss and lichen treatment to preserve roof coating.

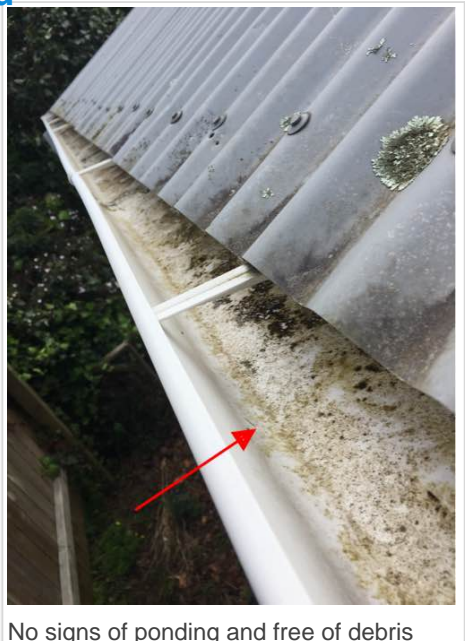
<p>Paint to fascia flaking off. Would recommend painting</p>
<p>Comments</p>	<p>No signs of ponding and free of debris</p> <p>The roof is in good condition. It appears there have been some sheets replaced. There are also new barge caps to the end as well as a new ridge cap to the rear section.</p> <p>There is evidence of some lichen and moss. This has potential to cause issues and it penetrates the roofs surface. It is recommended to consult a professional to clean and treat the moss and lichen.</p> <p>Gutters and downpipes are in good condition and are free of ponding and debris. Ongoing maintenance required.</p> <p>Roof to front of house was not inspected due to height and slope.</p>

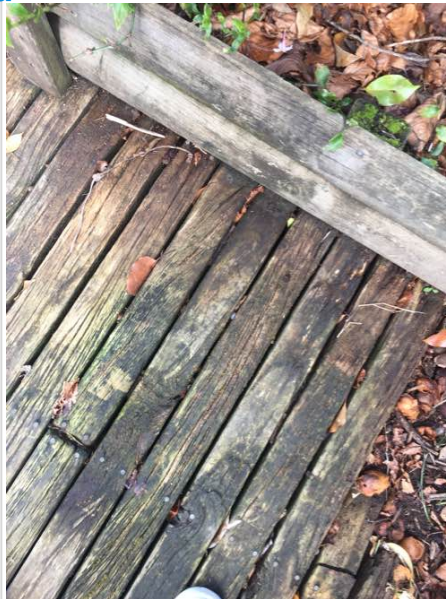
Decking to side of house is in poor condition

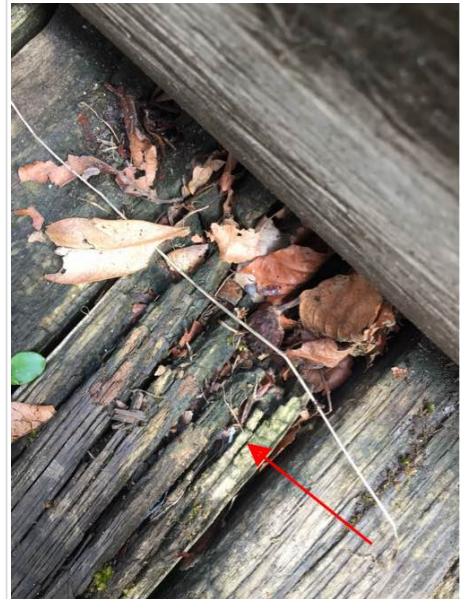
Boards rotting

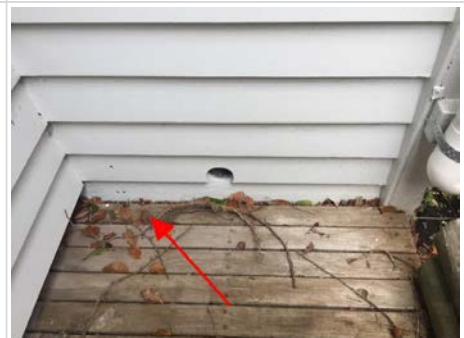
Decking in contact with cladding

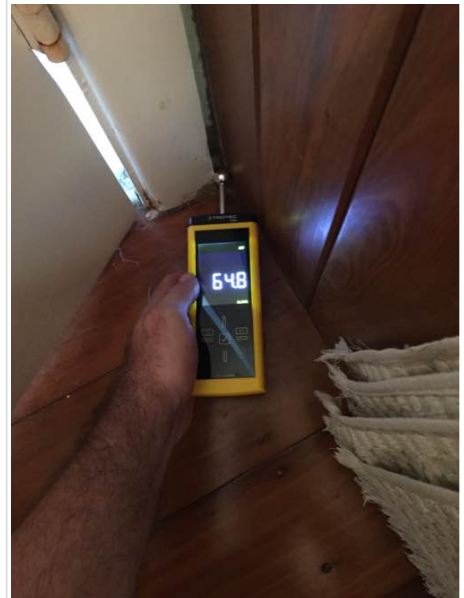
Slightly elevated moisture reading indicating Damp.

<p>Comments</p>	<p>Back of shower</p> <p>Back of shower</p> <p>Bathroom in good condition for age. Left side shower indicated a 'damp' reading. It appeared the shower had been recently used and the shower curtain is located above it, which could be the cause for the reading.</p> <p>The back side of the shower were checked and no elevated moisture levels were found.</p>
