Onsite Inspections Ltd
Po Box 300725
Albany,
Auckland 0752
info@onsiteinspections.nz
www.onsiteinspections.nz

Property Address	Sample Report
Photo Of Dwelling

Report Commissioned By	-
Email Address	-
Date of Inspection	27/09/2024
Time of Inspection	09:30 AM (13 GMT)
Inspection Conducted By	Justin Mackay
Present at time of inspection	Agent
Agent Name	-
Purpose of Report	Pre-Purchase Inspection

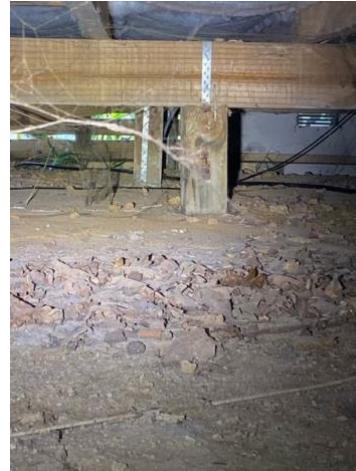
Pile to bearer connections good.

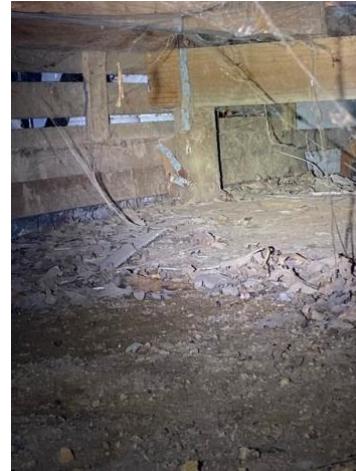
Piles and bearers appear in good condition.

The piles, bearers and joists appear in overall good condition.

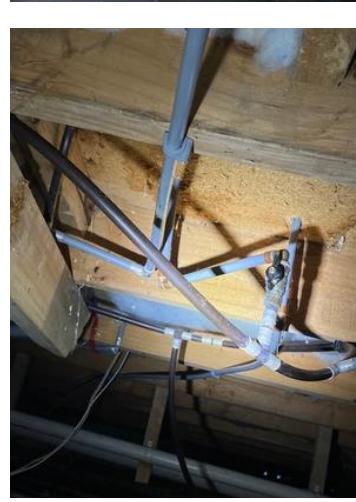
Appears older style buteline plumbing.

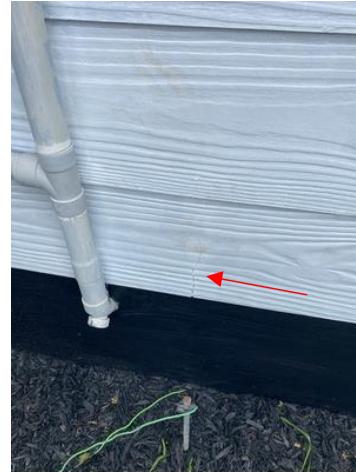
Gap to jointer.

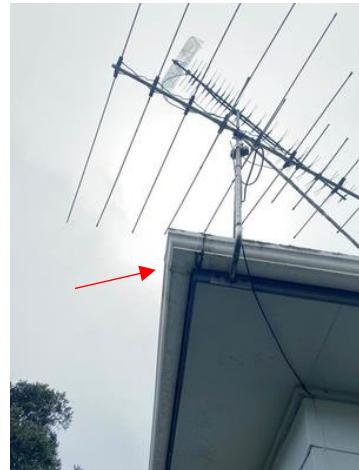
Drip to gutter to this area.

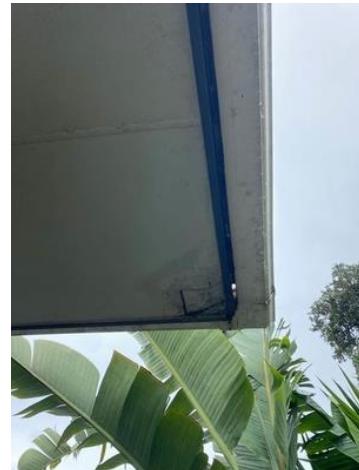
Moisture damage to soffit.

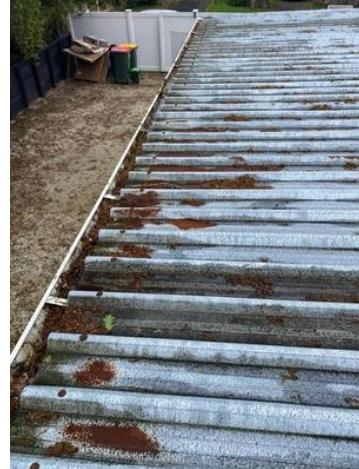
Corrosion to shed roof.

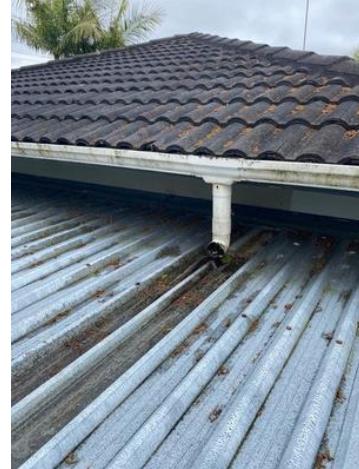
Recommend installing spreader.

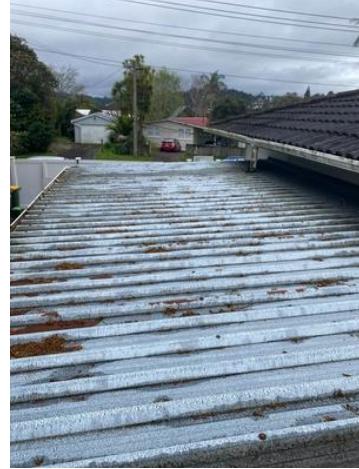
Roof in poor condition.

<p>Chipped tile.</p>
Comments		<p>Overall, the roof is in a condition reflective of the age of the home and a lack of maintenance for a prolonged period of time and requires attention.</p> <p>Cracked tiles and silicone repairs as noted.</p> <p>Recommend contacting a licensed roofer/roof coating expert for advice/remedial action.</p> <p>Gutters require cleaning. Regular maintenance is required to ensure gutters are free of debris and ensure that water falls the correct way.</p> <p>Roof leak to area in lounge. This appears to be around the Sky dish.</p>

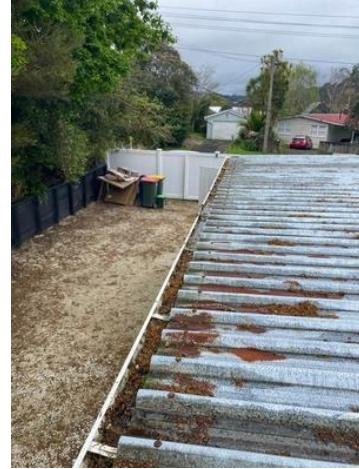
Gutter requires attention.

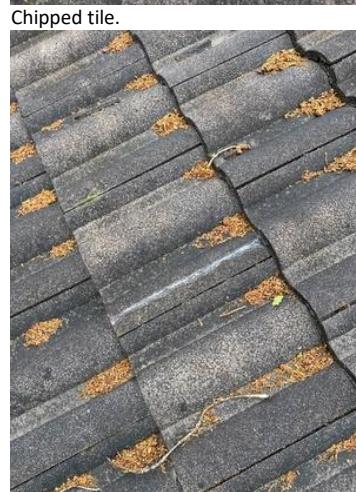
Missing pointing.

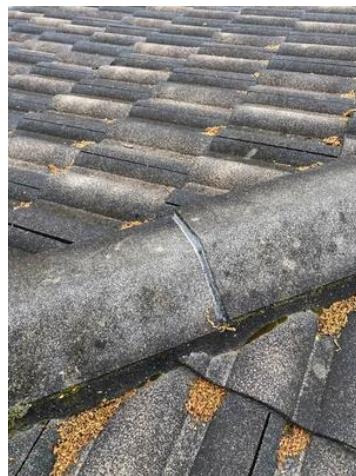
Silicone repairs to tiles.

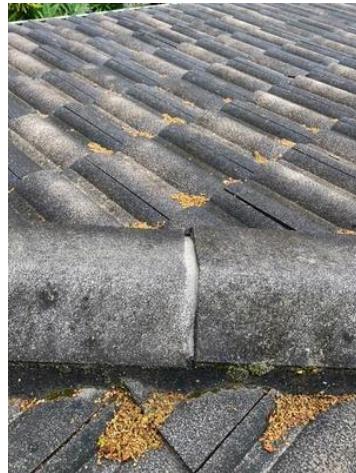
Cracked and missing pointing.

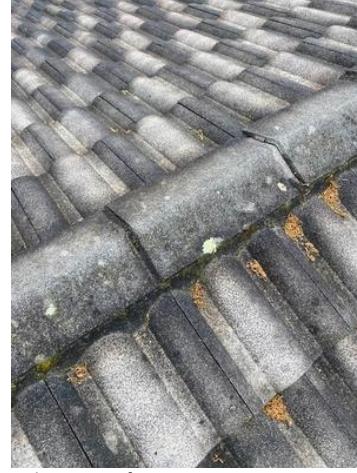
Missing pointing.

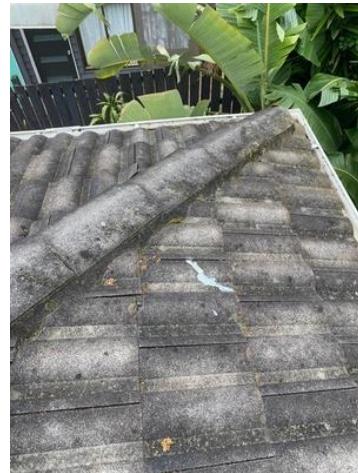
Gutter requires cleaning.

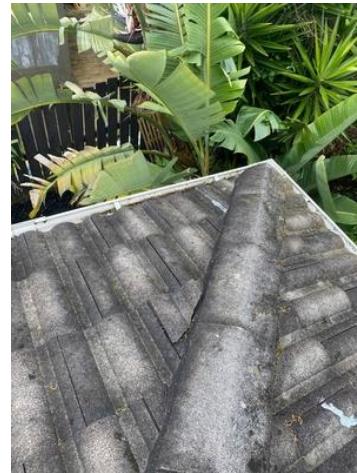
Silicone repairs.

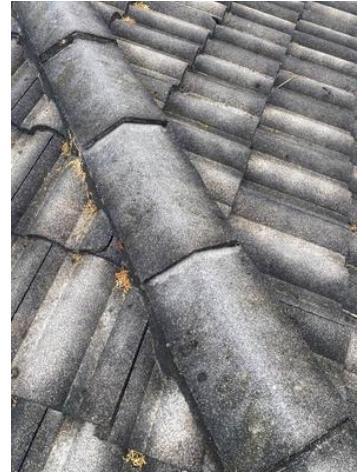
Roof dirty to this area.

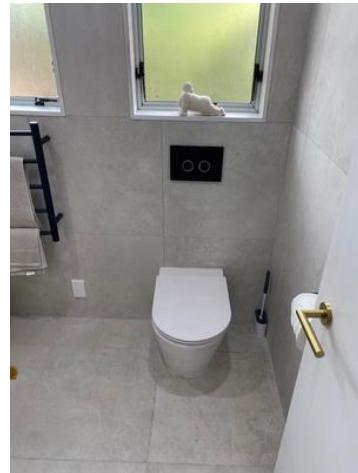
In wall cistern.

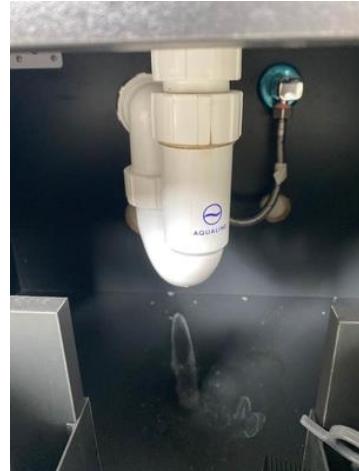
Well sealed.

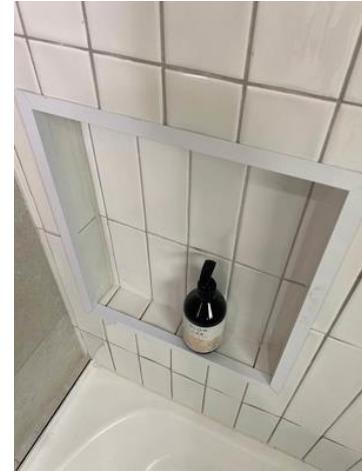
No visible leaks.

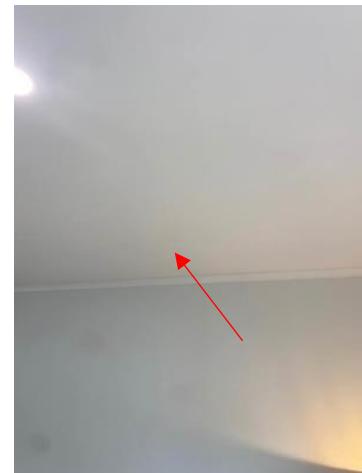
Repairs to ceiling.

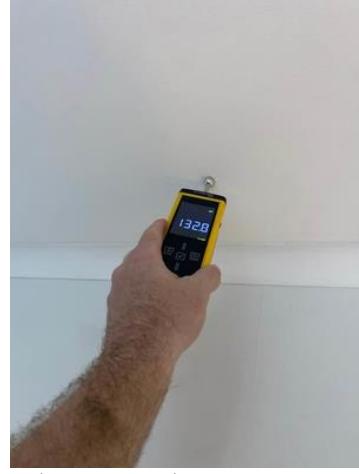
Thermal anomaly to this area.

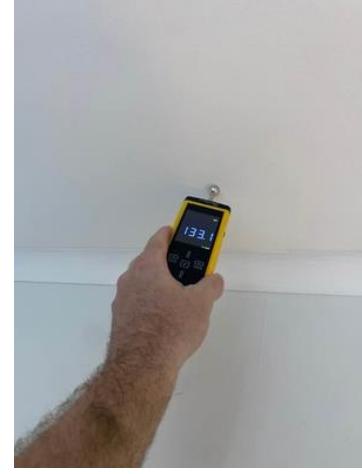
High moisture readings.

Elevated moisture reading to area as noted. Recommend further investigation.

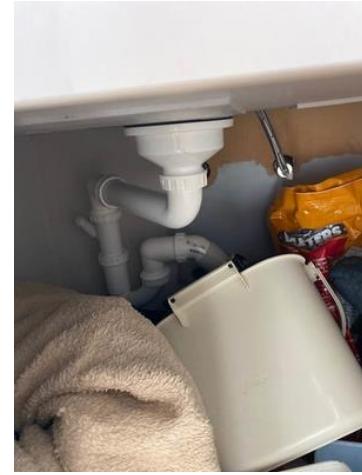
Well sealed.

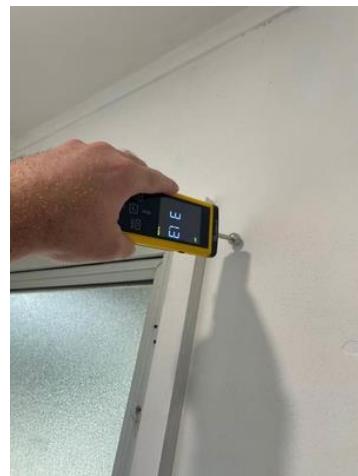
Elevated moisture reading.

Comments	Elevated moisture reading to side of laundry door. Recommend further investigation.		
Bedrooms/Office			
Overall Condition	Good		
Checked for Moisture	Yes		
Photos

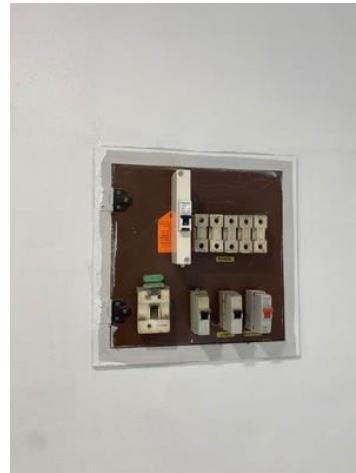
Older style switch board, no RCD protection.

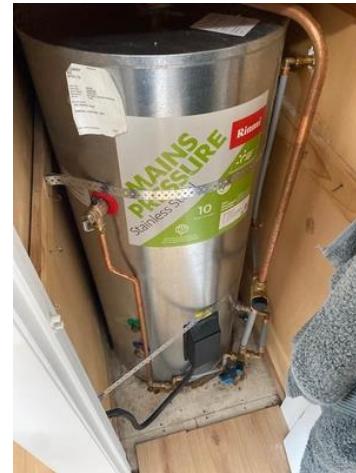
No visible leaks.

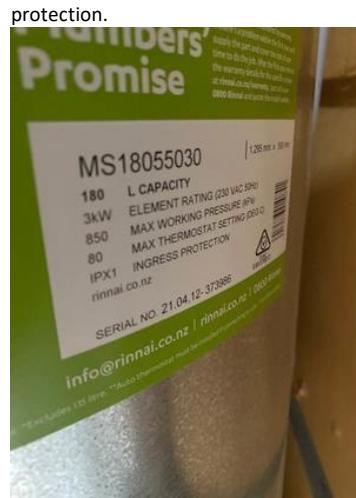
Manufactured 2012.
