Onsite Inspections Ltd Property

Property Address	1 Sample Way
Photo Of Dwelling

Inspection Details

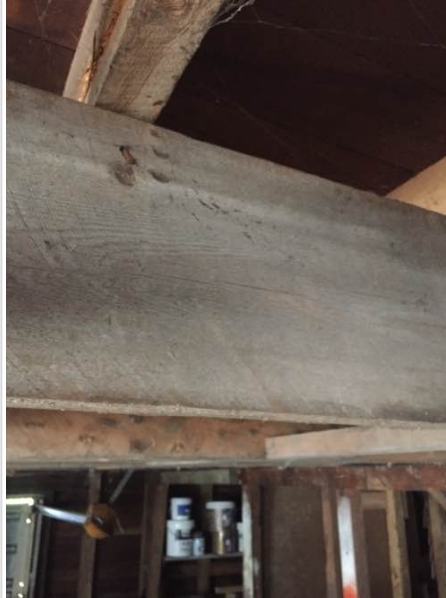
No evidence of borer or similar insect to timber at time of inspection

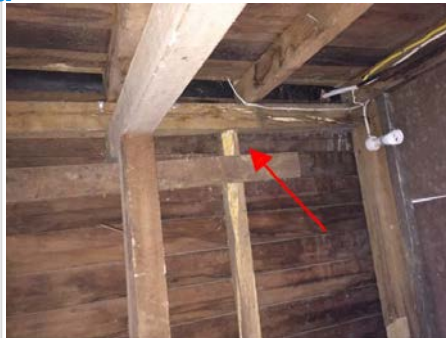
Bearer over span. Has props which go to ground.

There are a couple of areas which require remediation as outlined in the subfloor section. Recommend an LBP to add additional beams and supports where required.

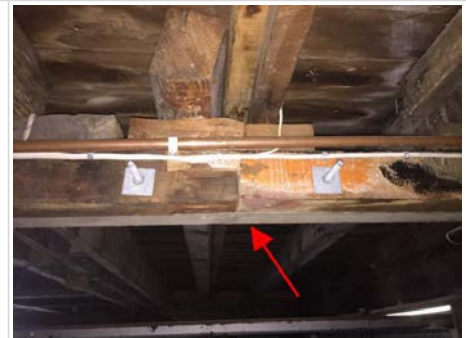
Join with no support under it. Requires attention.

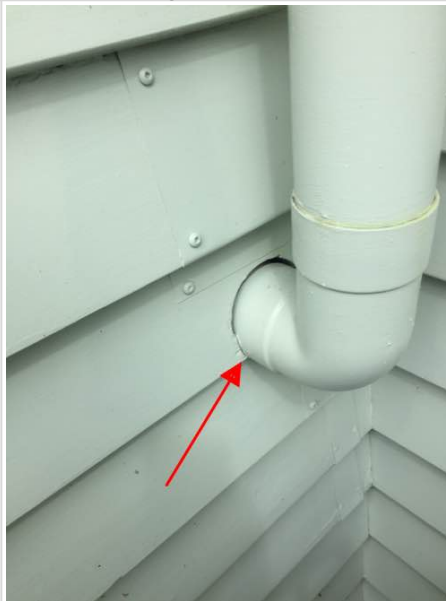
Penetration not sealed correctly

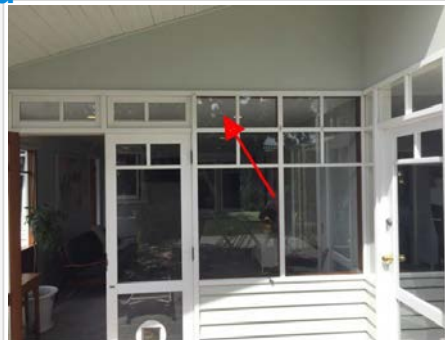
No head flashing

Lack of or poorly installed head flashings can cause issues with water ingress.

Both Garage doors do not have head flashings. Seeing as this is below floor level, it is not a cause for concern, however it is recommended that they are sealed with an outdoor silicone and regularly checked to help stop water ingress.

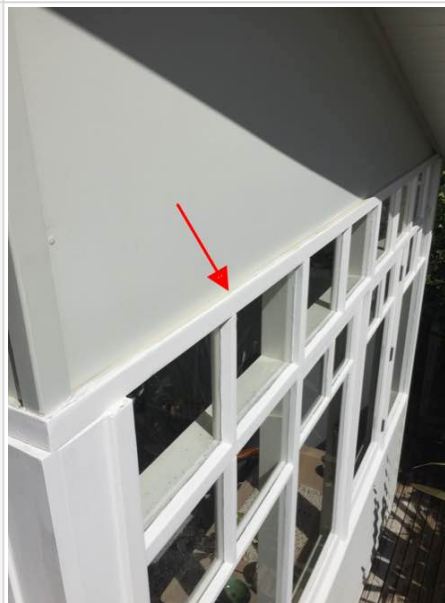
No head flashing

The windows to the rear of the house (lounge, office, children's play room) do not have head flashings. The lounge and children's play room have cover from the soffit overhangs and are of less of a risk, however it is recommended that these areas are constantly monitored to ensure the sealant does not deteriorate and allow water inside, especially to the office.

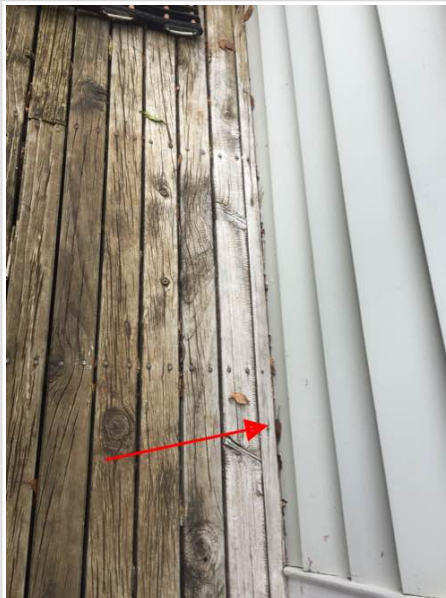
Decking in contact with cladding

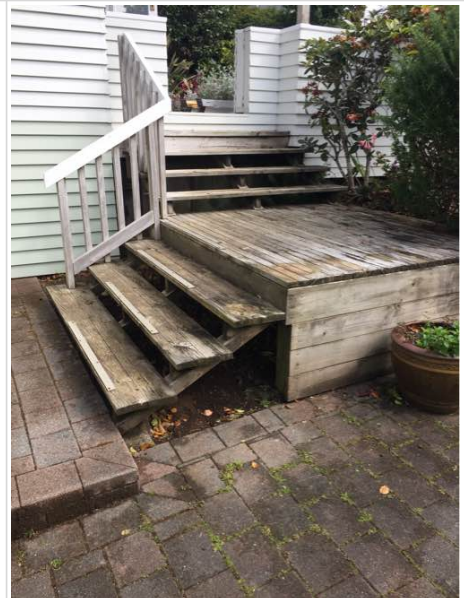
Timber to landing appears to be of correct treatment.

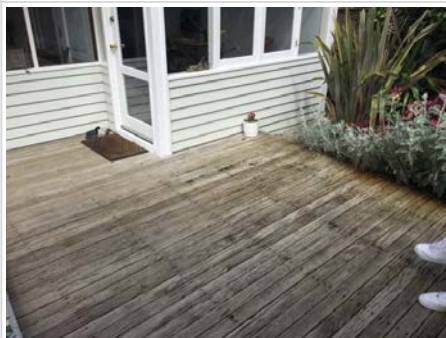
Main deck is in average condition
