Onsite Inspections Ltd Property

Property Address	1 Sample Way
Photo Of Dwelling

Inspection Details

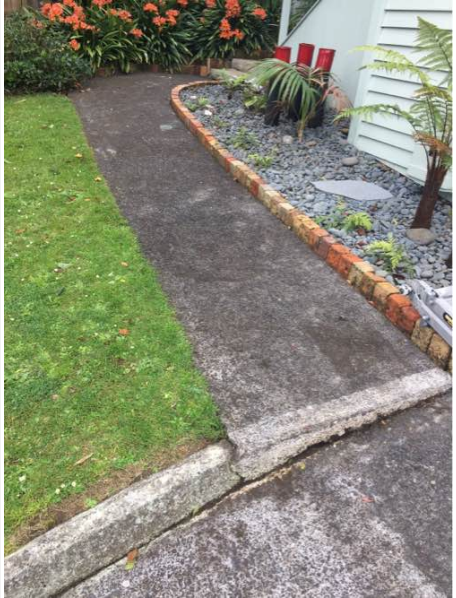
Comments	Paths and drive are even and not slippery. They are in good condition for their age. There is some signs of some small cracks and patches that have been repaired. All consistent with the age of the property.

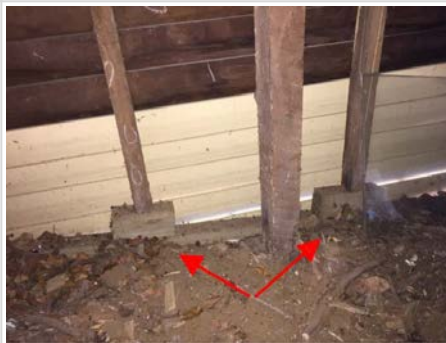
Props under bearer. Requires attention

There are a couple of areas which require remediation as outlined in the subfloor section. Recommend an LBP to add additional beams and supports where required.

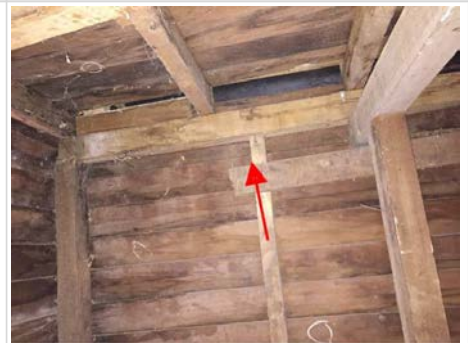
Bearer is over span.

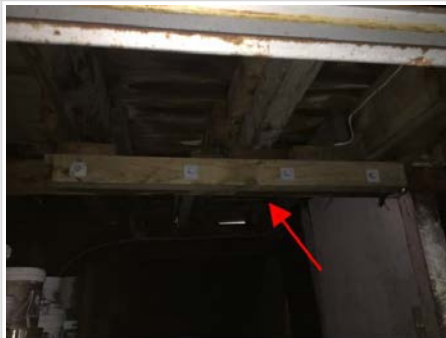
Flitch plate to bearer below joists

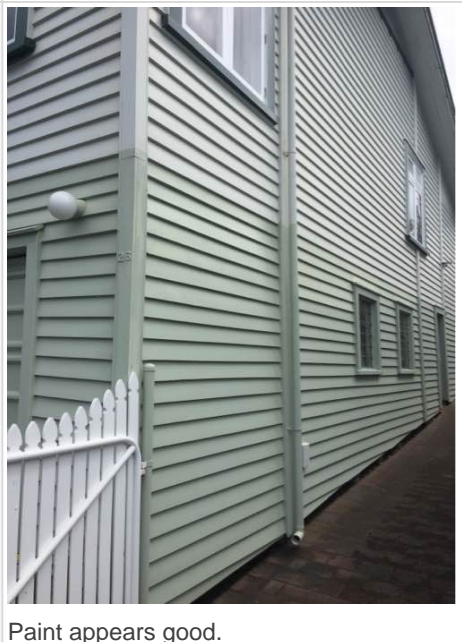
<p>Paint appears good.</p>

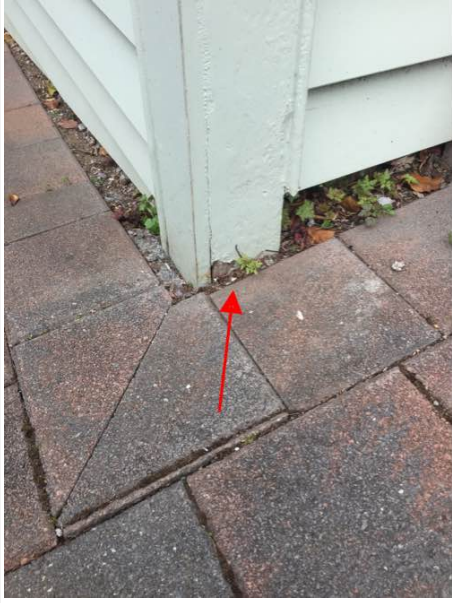
<p>Is there adequate ground clearance?</p>	<p>Facing in contact with ground.</p>	
<p>Is the Cladding on a cavity?</p>	<p>No</p>	
<p>Are the penetrations adequately sealed?</p>	<p>No</p>	
<p>Photos</p>

High ground levels and cladding being in contact with the ground are known causes for timber rotting. Ongoing maintenance is recommended to ensure there is no build up of debris, as this can trap moisture.

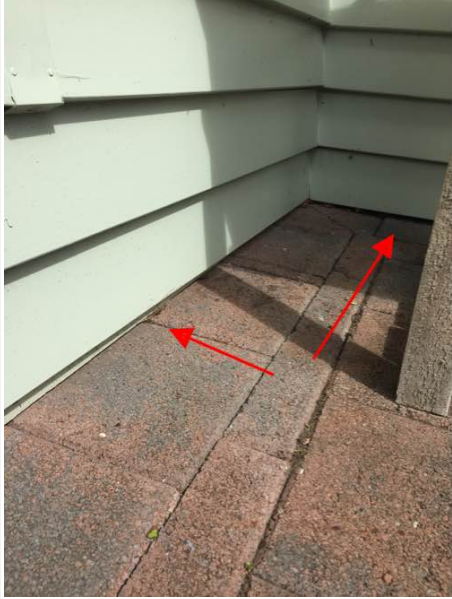
<p>Cladding in contact with ground.</p>	<p>Paint peeling off in small section to front of house.</p>

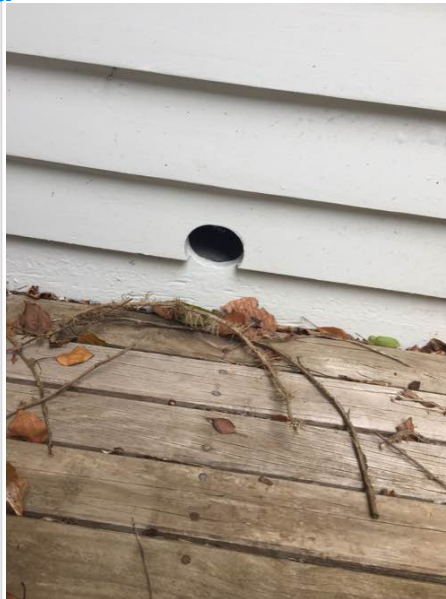
Hole to cladding should she sealed

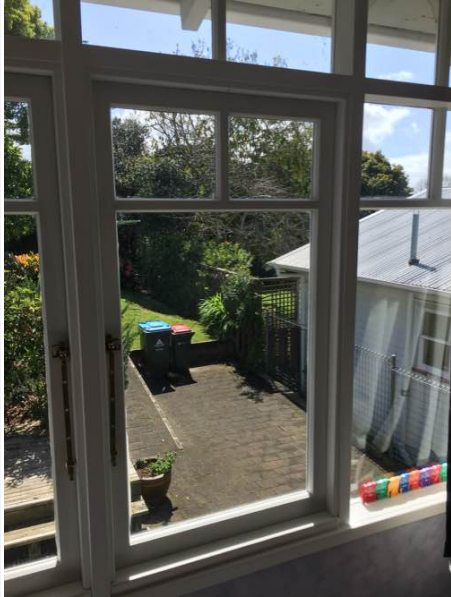
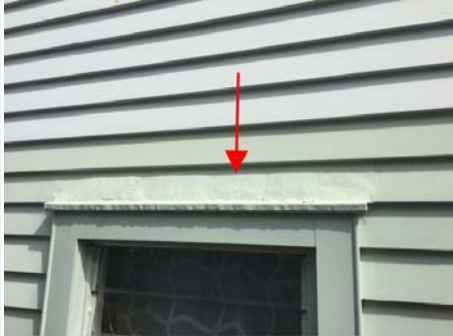
<p>Head flash present</p> <p>Joinery In good condition for age</p>

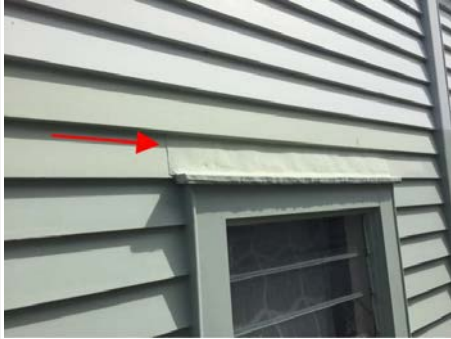
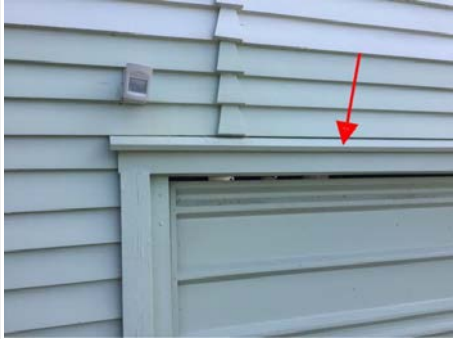
<p>Head flashing present</p> <p>Timber eyebrow to garage door.</p>

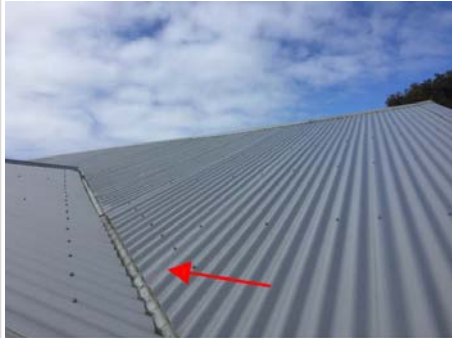
<p data-bbox="533 918 750 952">Valley free of debris</p>

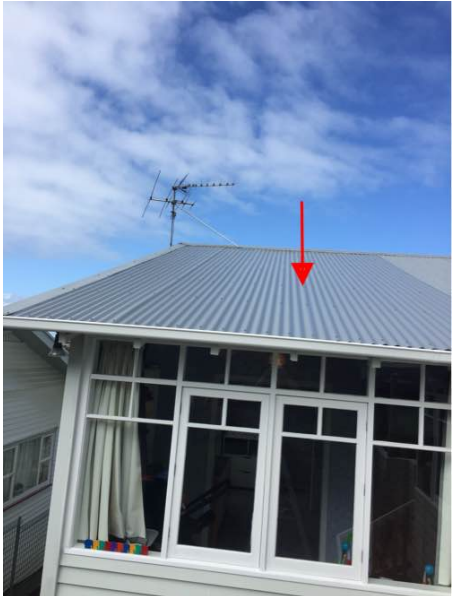
<p data-bbox="999 1176 1300 1209">Sheets have been replaced</p>

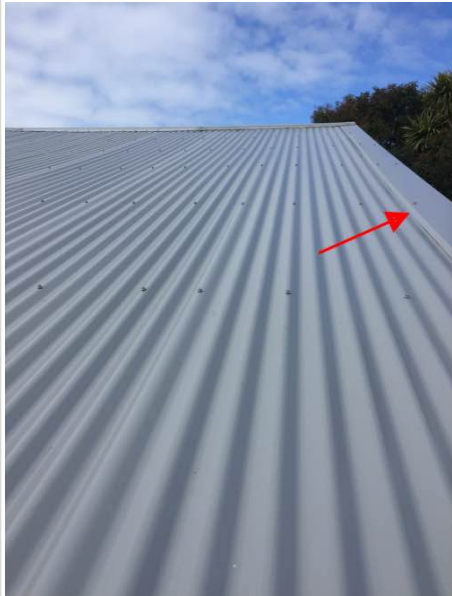
<p data-bbox="533 1816 973 1881">Sheets in good condition with new barge caps</p>

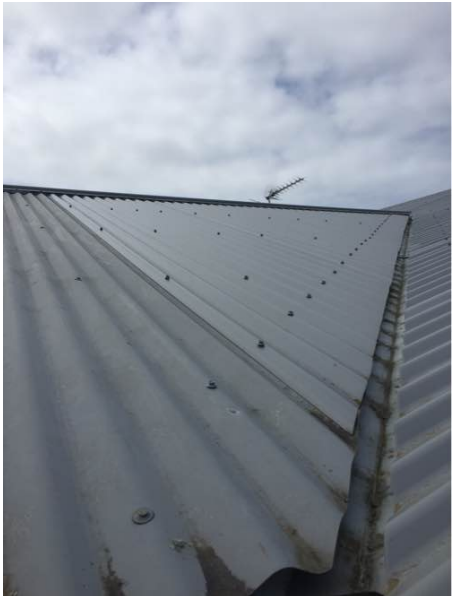
<p data-bbox="999 1816 1276 1850">Sheet has been replaced.</p>

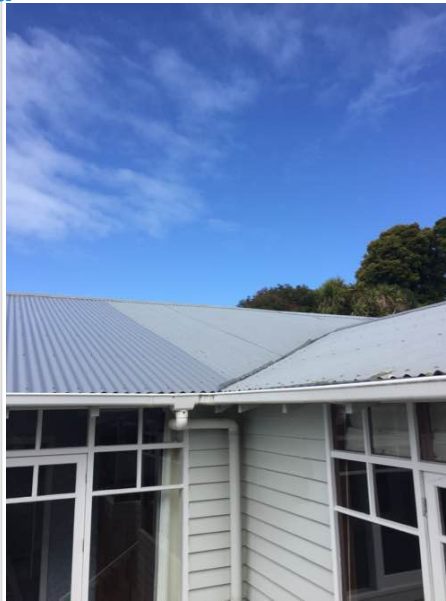
New and existing sheets

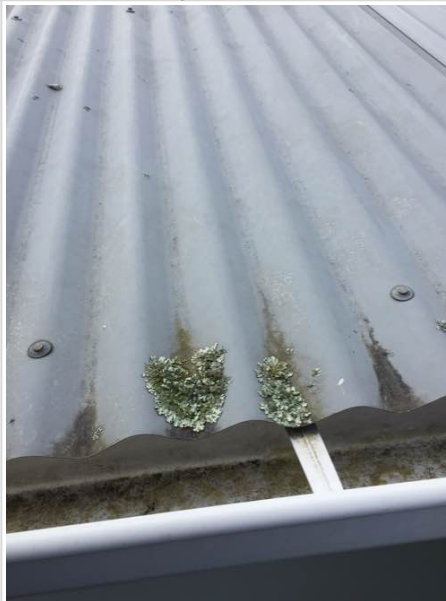
Lichen and Moss

The roof is in good condition with some sheets being replaced. Recommend moss and lichen treatment to preserve roof coating.

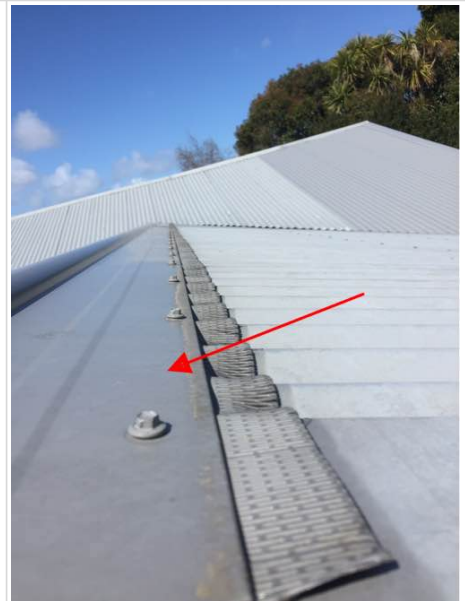
New ridge cap

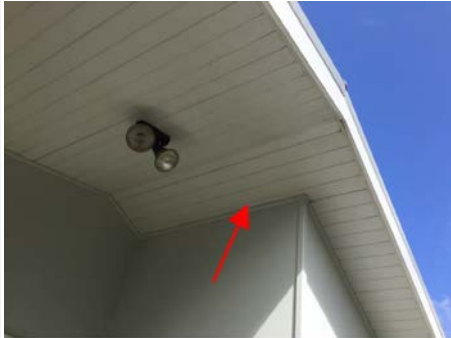
<p data-bbox="534 891 810 920">No reverse slope flashing</p>

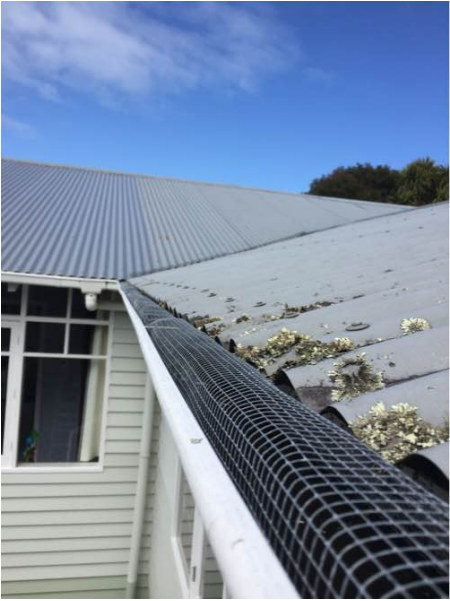
<p data-bbox="1002 1149 1139 1178">Gutter guard</p>

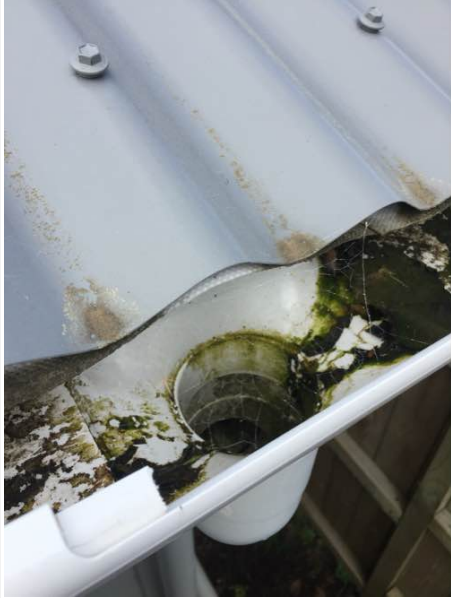
<p data-bbox="534 1792 687 1821">Free of debris</p>

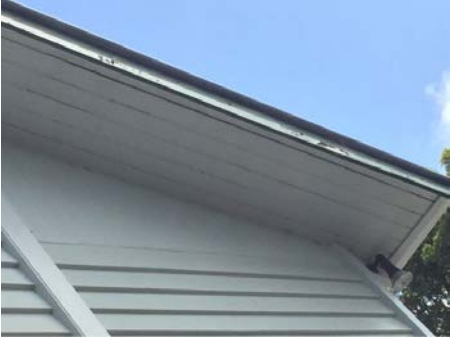
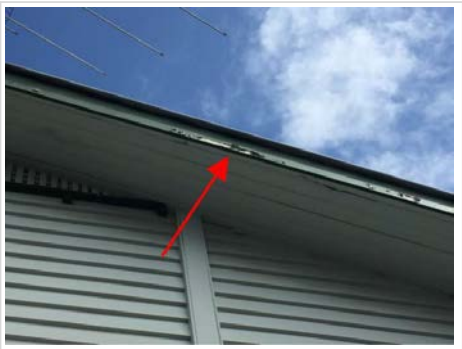
<p>Paint to fascia flaking off. Would recommend painting</p>
<p>Comments</p>	<p>No signs of ponding and free of debris</p> <p>The roof is in good condition. It appears there have been some sheets replaced. There are also new barge caps to the end as well as a new ridge cap to the rear section.</p> <p>There is evidence of some lichen and moss. This has potential to cause issues and it penetrates the roofs surface. It is recommended to consult a professional to clean and treat the moss and lichen.</p> <p>Gutters and downpipes are in good condition and are free of ponding and debris. Ongoing maintenance required.</p> <p>Roof to front of house was not inspected due to height and slope.</p>

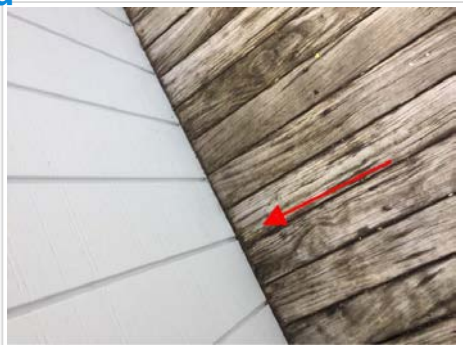
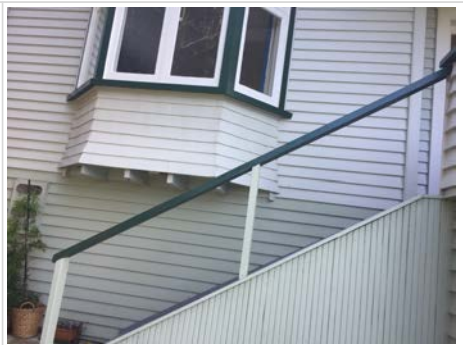
Comments	<p>Decking in contact with handrail wall</p> <p>No balustrades to entry stairs.</p> <p>Overall the deck is average-poor condition. There are some boards that are rotten and require replacing.</p> <p>The main deck is in average condition. The decking is in contact with the cladding. Decking should be 12mm off the building for a 'wash down gap'. Constant contact makes it difficult for water and debris to escape, which over time can cause rot.</p> <p>Stairs appear to be constructed from the correct materials.</p> <p>Unable to inspect the deck structure do to no access.</p>

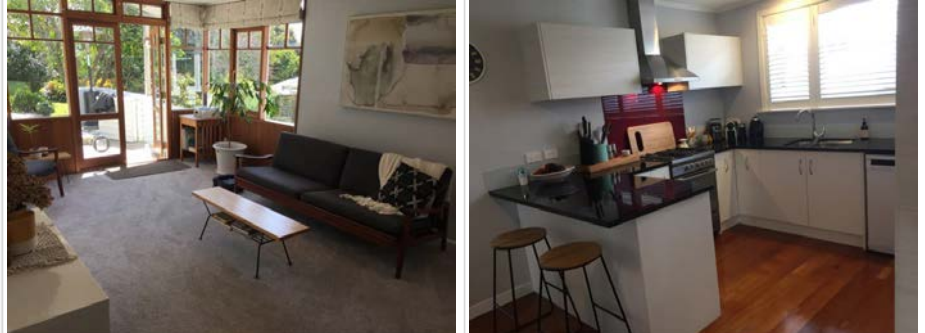
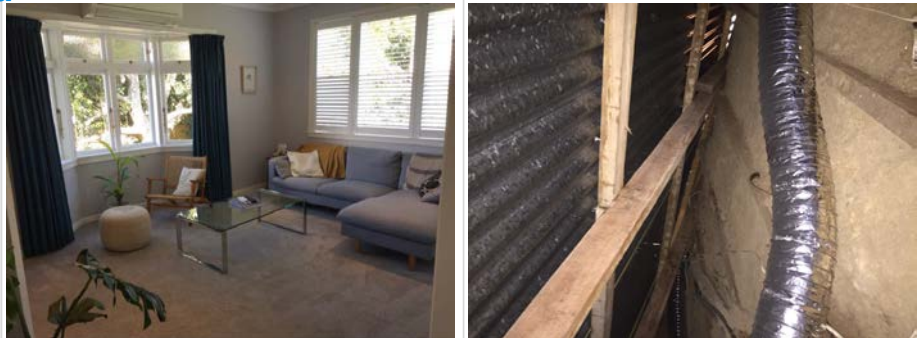
The inside is in good condition. The Roof space has insulation. There were no signs of rodents at time of inspection. Ceiling space had good ventilation. Not all of the roof space was inspected do to lack of access.

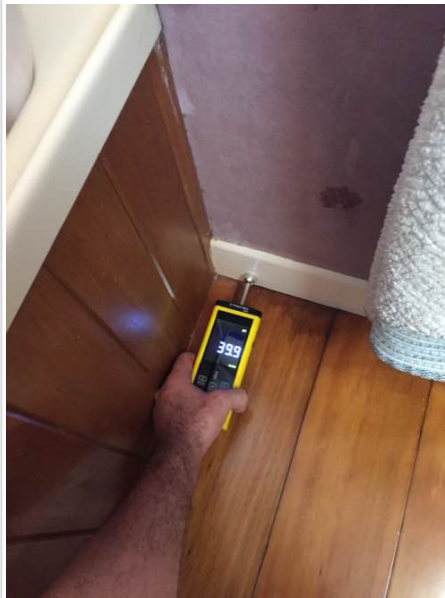
Normal

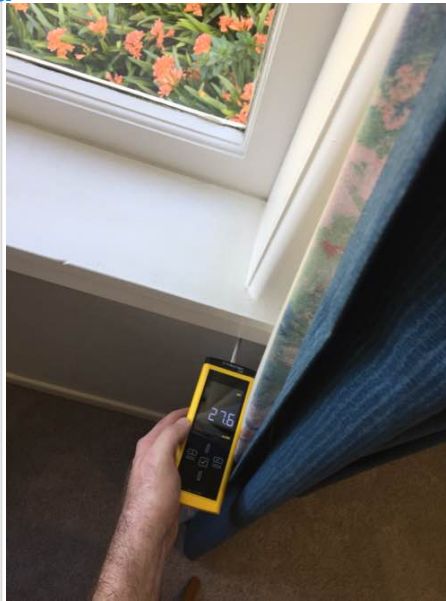
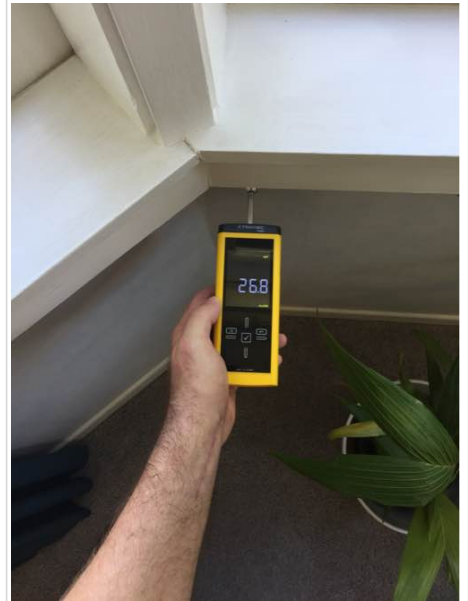
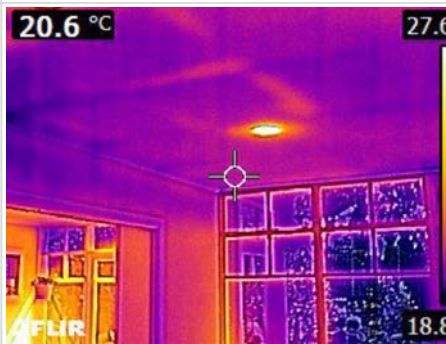
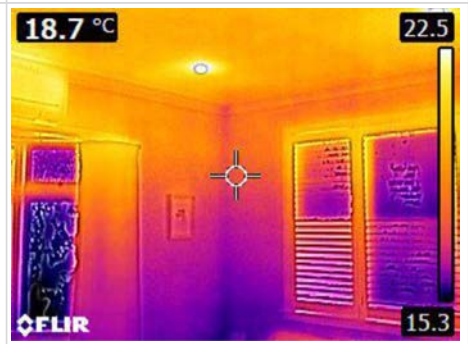
Comments	Both lounges in good condition. No abnormal thermal images or elevated levels of moisture were recorded at time of inspection.

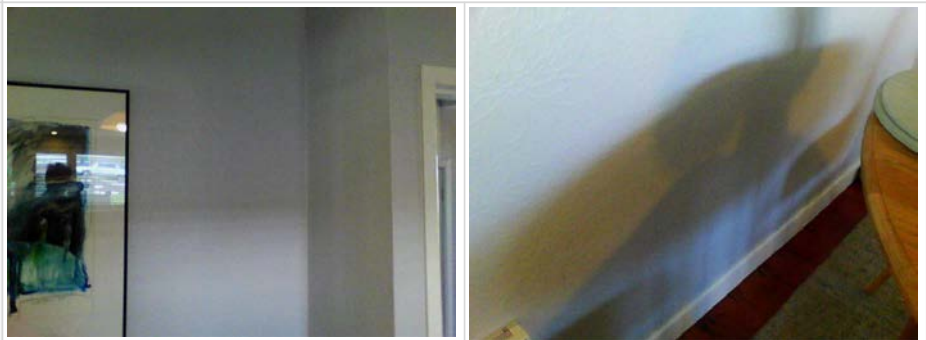
Comments	No abnormal thermal images or elevated levels of moisture were recorded at time of inspection.

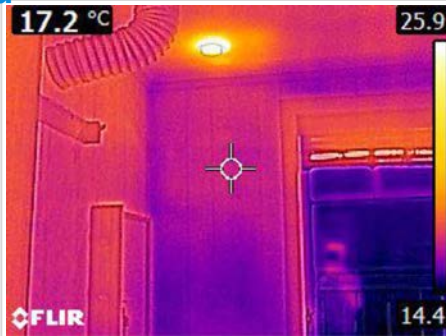
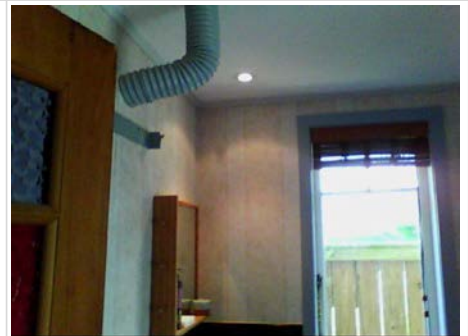
No abnormal thermal images or elevated levels of moisture were recorded at time of inspection.

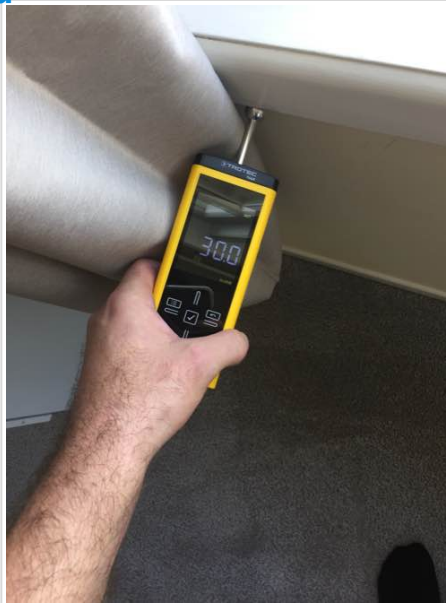
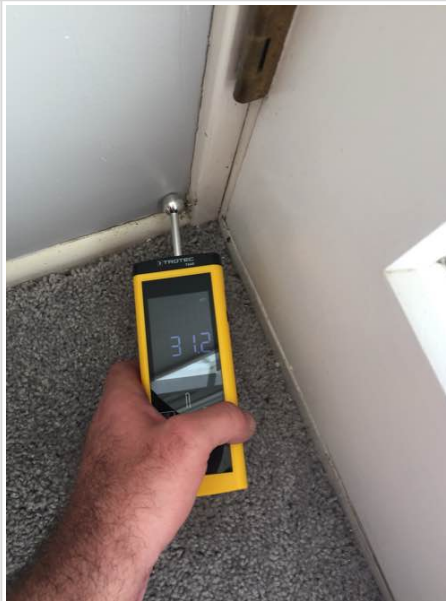
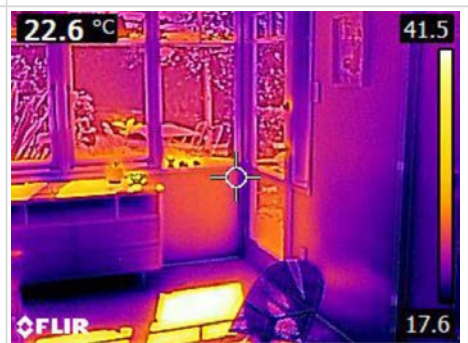
<p>Comments</p>	<p>No abnormal thermal images or elevated levels of moisture were recorded at time of inspection.</p>

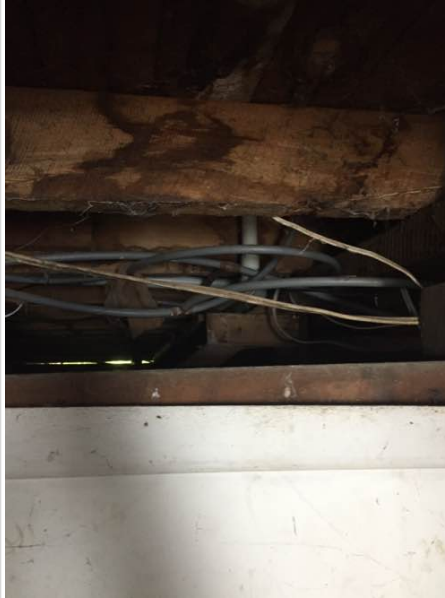
Under house plumbing appears new

Plumbing appears to be relatively new with buteline pipes. No visible leaks at time of inspection.

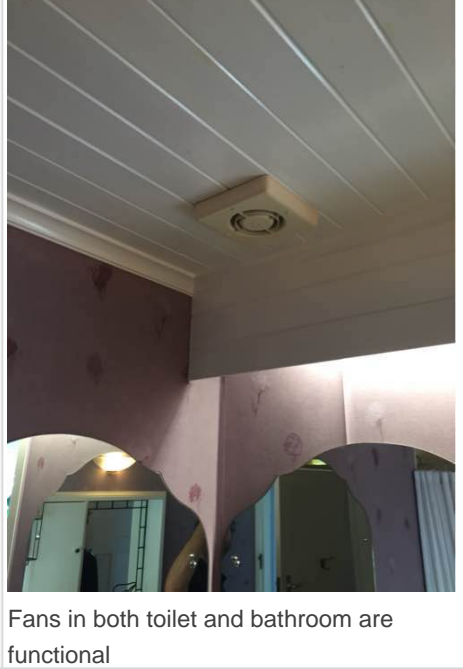
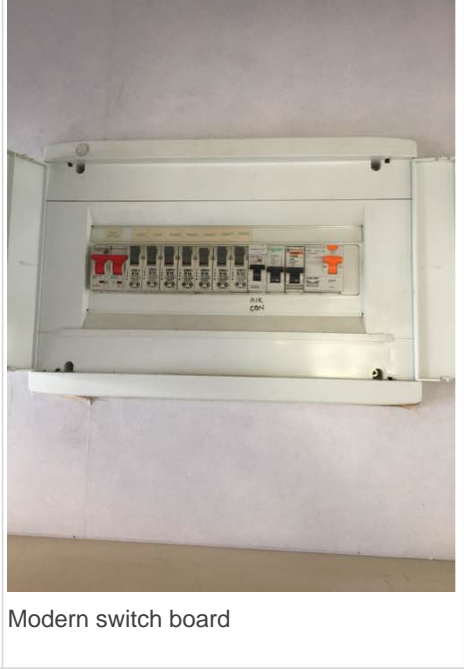
<p>Comments</p>	<p>Fans in both toilet and bathroom are functional</p> <p>Modern switch board</p> <p>Both Fans are in working condition. Appears the electrical has been upgraded at some point and has a relatively modern switch board. All wiring under house is secured out of way. All lights worked at time of inspection.</p> <p>No appliances or power points were tested.</p>
