Onsite Inspections Ltd
Po Box 300725
Albany,
Auckland 0752
info@onsiteinspections.nz
www.onsiteinspections.nz

Property Address	Sample Report
Photo Of Dwelling

Report Commissioned By	-
Email Address	-
Date of Inspection	27/09/2024
Time of Inspection	09:30 AM (13 GMT)
Inspection Conducted By	Justin Mackay
Present at time of inspection	Agent
Agent Name	-
Purpose of Report	Pre-Purchase Inspection

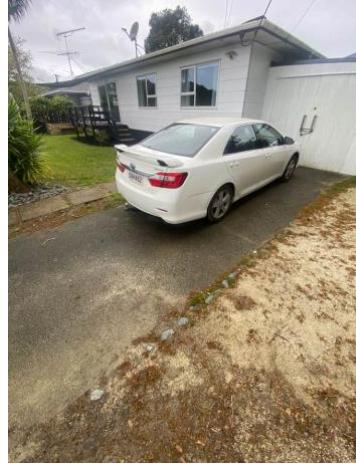
Drive overall average.

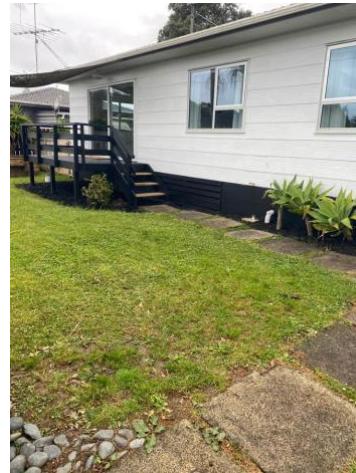
Pavers average.

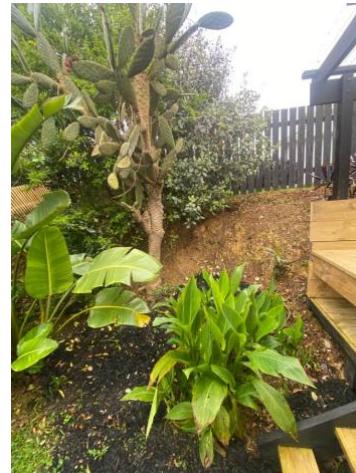
No retaining wall to this area.

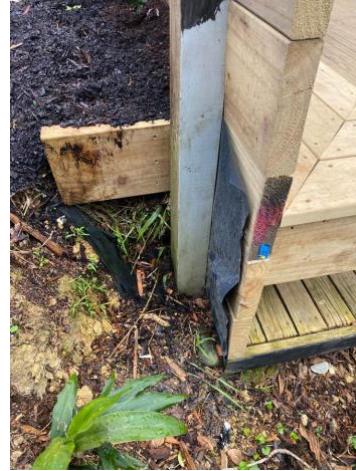
Incorrect timber treatment to retaining wall.

Comments		<p>The drive is in overall average condition for the age of the home. No visible ponding at time of inspection. Recommend ensuring drains are clean and free of debris.</p> <p>Retaining wall constructed with incorrect treatment of timber (H3.2). This timber is not designed to be in contact with ground. Timber should be H4. Large post spacings. This is an indication of a lack of knowledge in basic building practices, which is a cause for concern.</p> <p>No visible drainage to base of retaining wall.</p>

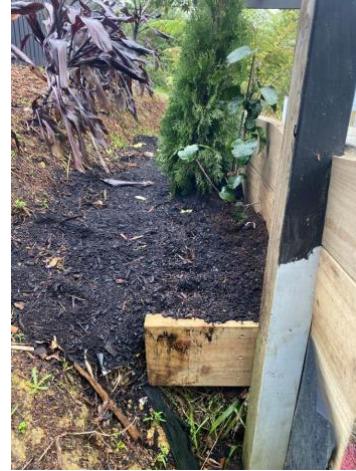
No drainage to rear of wall.

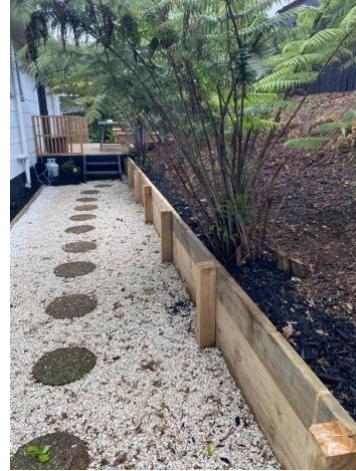
Incorrect treatment. Wall on slight lean.

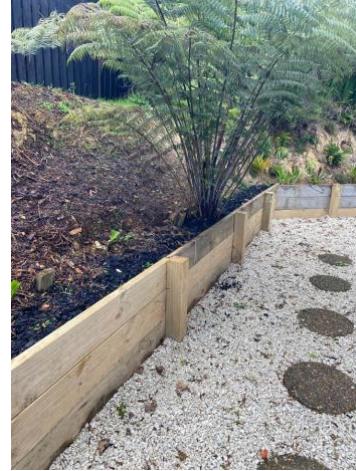
Small diameter posts and posts spacings far apart.

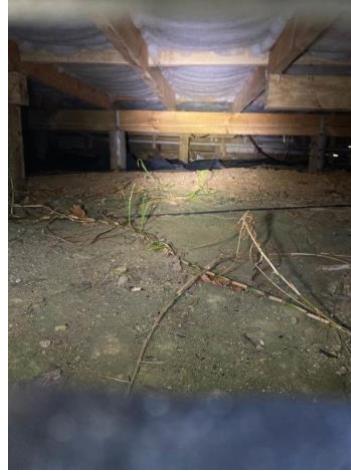
No ground moisture barrier.

The insulation has a good, snug fit and is of the correct 'R' rating. There is no ground moisture barrier.

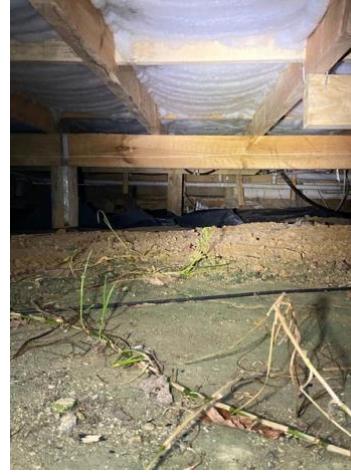
Insulation has a good, snug fit.

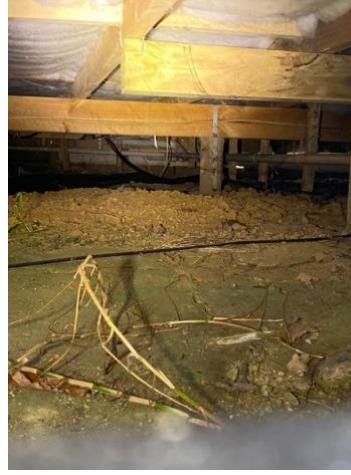
Pile to bearer connections good.

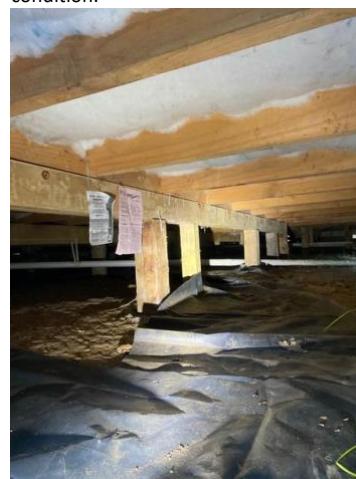
Insulation of the correct 'R' rating.

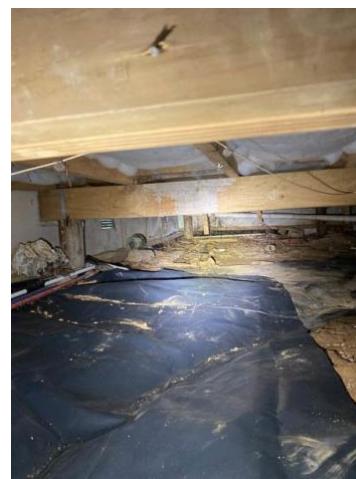
Ground damp to this area.

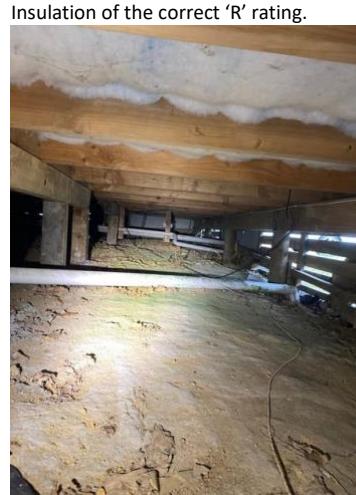
Ground dry.

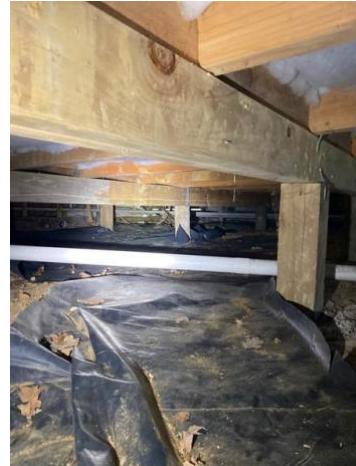
Inadequate ground moisture barrier.

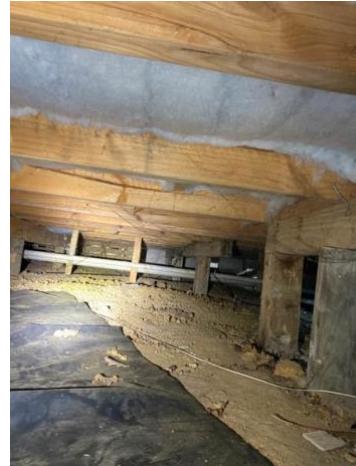
Ground overall dry.

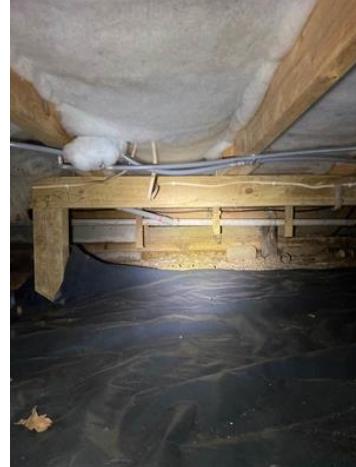
Ground damp.

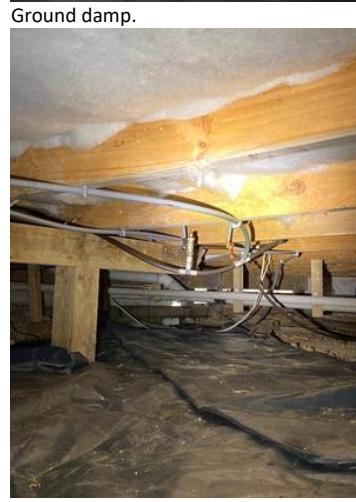
Appears older style buteline plumbing.

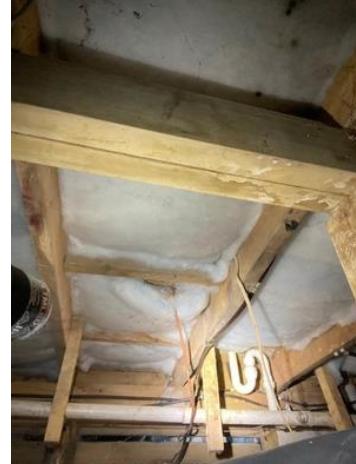
No visible leaks.

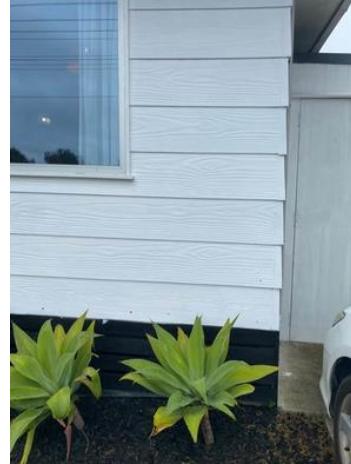
<p>Paint finish average.</p> </div> <div style="text-align: center;">

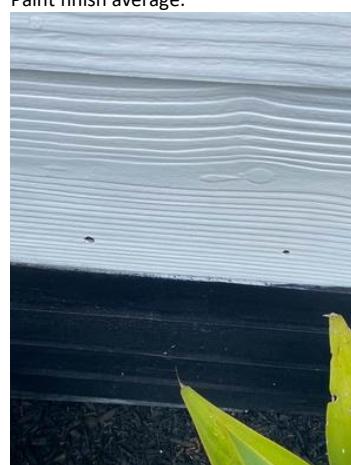
<p>Holes to lower board require sealing.</p> </div> </div>

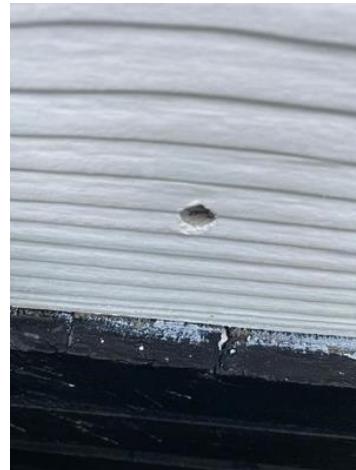
Cladding is fibre cement.

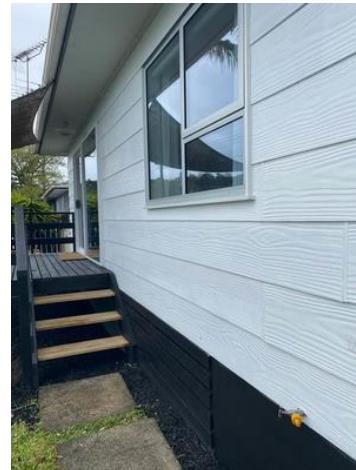
Boards overall good.

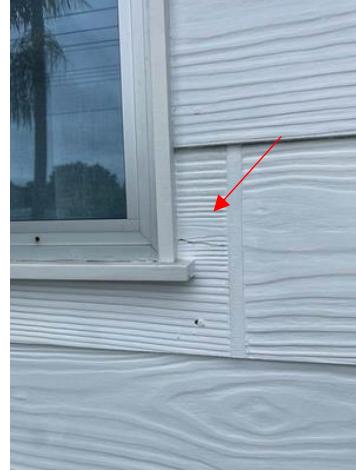
Crack to cladding.

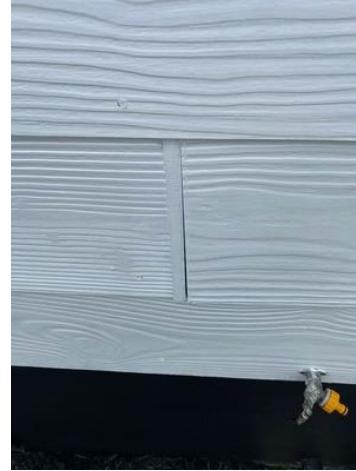
Gaps to jointer. Recommend sealing.

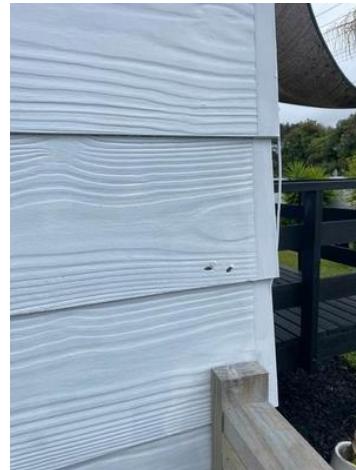
Holes to cladding. Require sealing.

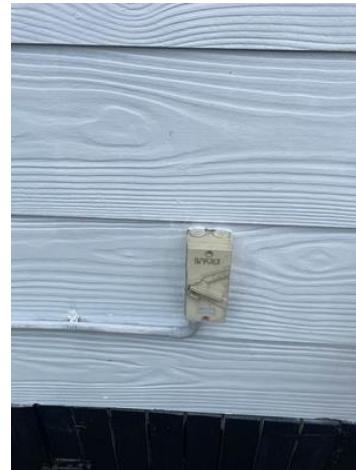
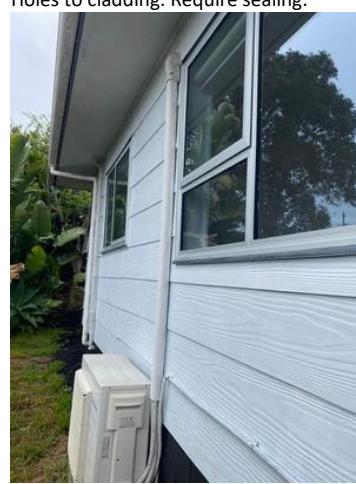
Paint finish to this face average.

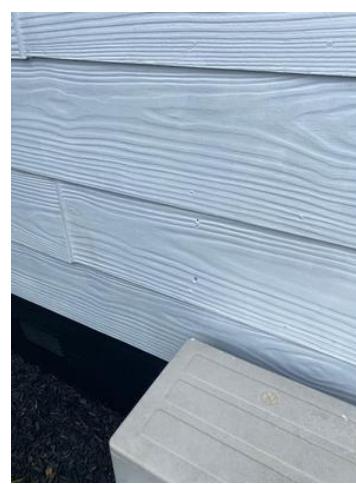
Small holes to cladding.

Comments	<p>Recommend ensuring good seal to internal corners.</p> <p>Overall, the cladding is in a condition reflective of the age of the home.</p> <p>There are some remedial items which need attention as well as ongoing, regular maintenance.</p> <p>Holes are cracks in the cladding can cause moisture ingress. Seal and replace where required.</p> <p>Paint finish average. It is recommended to ensure a good paint finish is maintained to help reduce the risk of moisture ingress and help prolong the life of the cladding.</p> <p>Ongoing maintenance required.</p>	<p>Holes require sealing.</p>

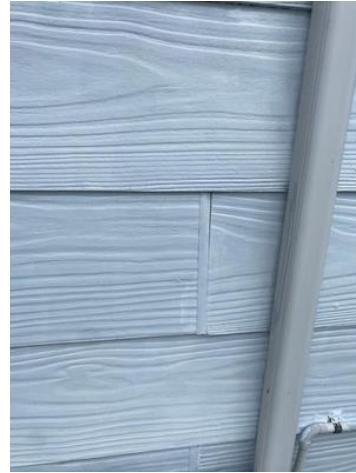
Gap to jointer.

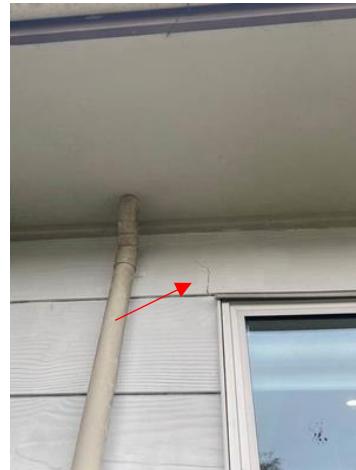
Crack to cladding.

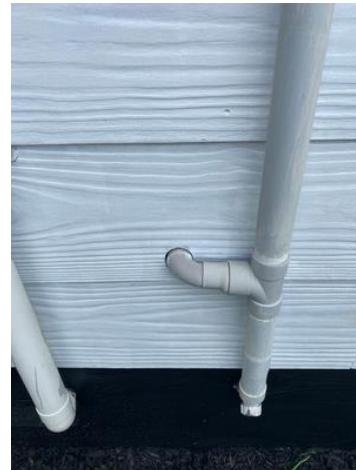
Penetration requires sealing.

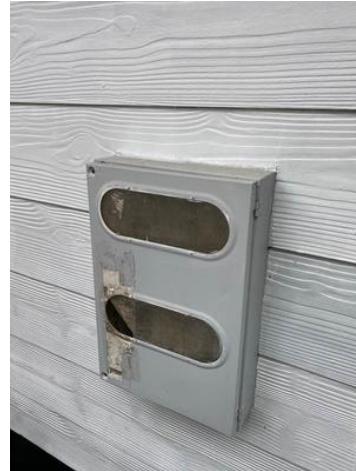
No head flashing. Appears well sealed.

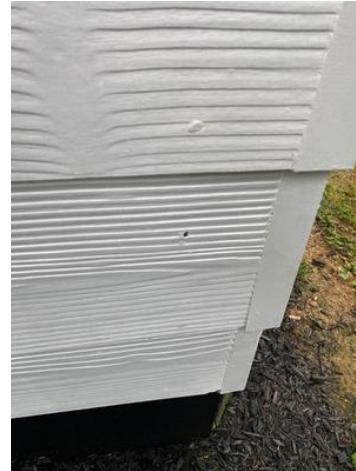
Recommend sealing hole.

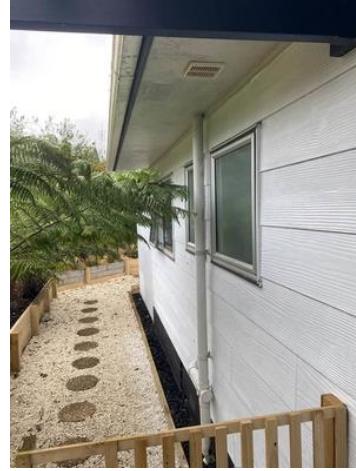
Cladding to rear of building overall good.

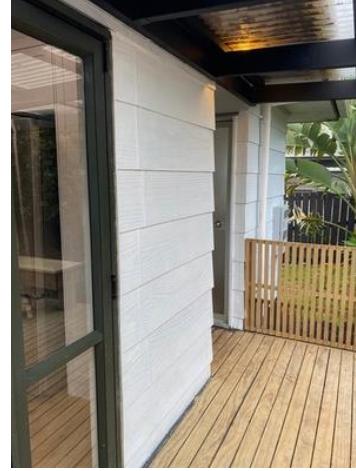
Possible alteration to this area.

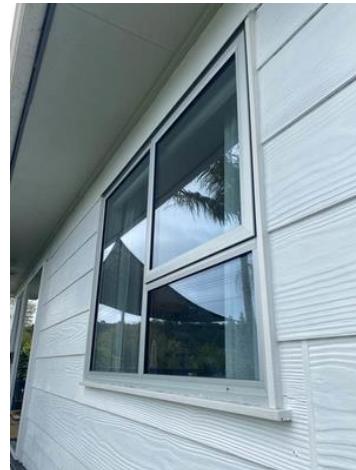
Retrofitted double glazing.

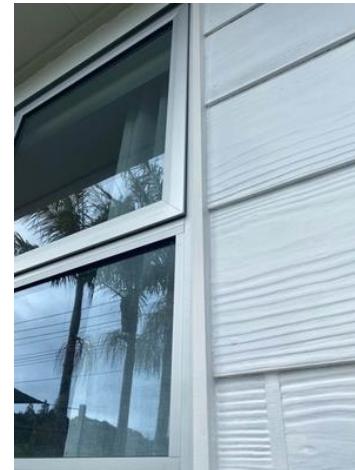
Side of window well sealed.

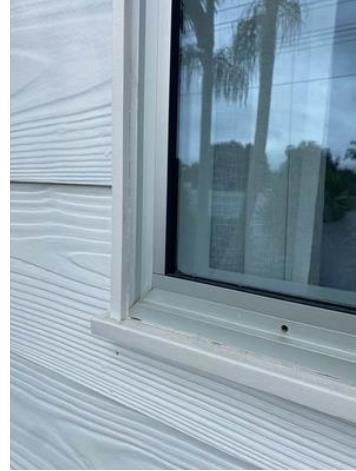
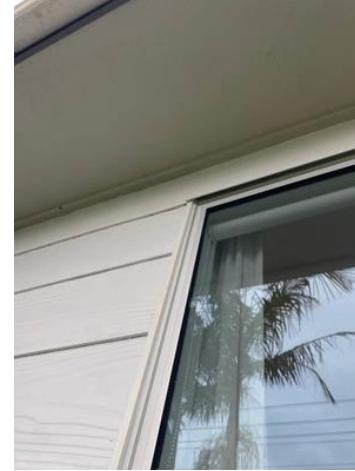
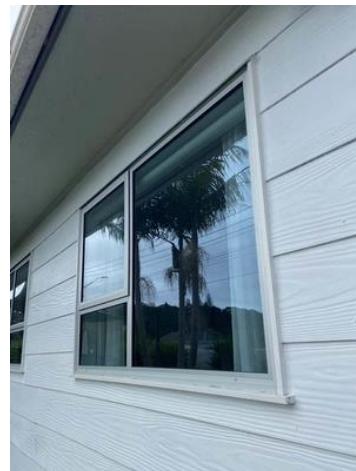
Joinery overall good.

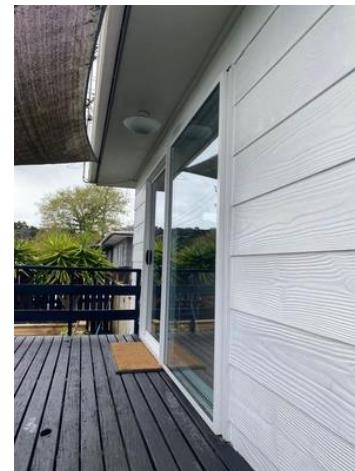
Unit replaced.

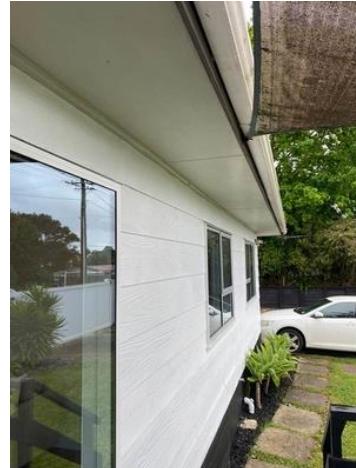
Height of windows in relation to soffit overhang good.

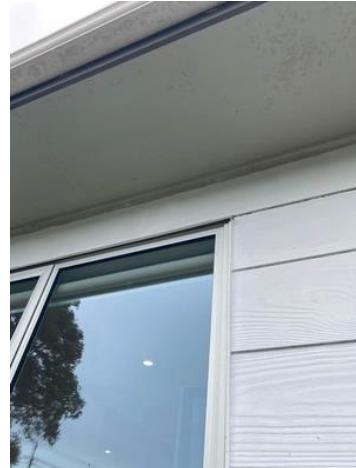
Minimal cover to head flashing.

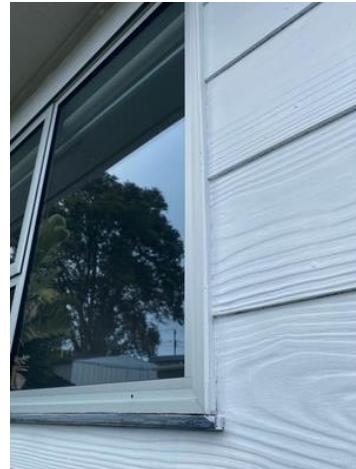
Recommend ensuring good seal to side of windows.

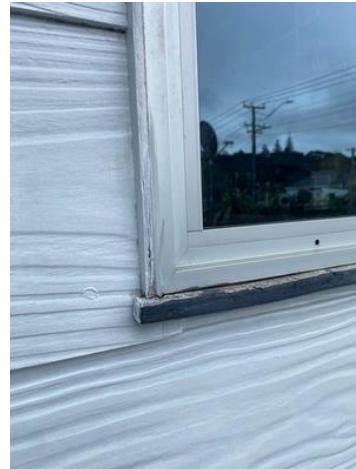
Some deterioration to sill and scribes.

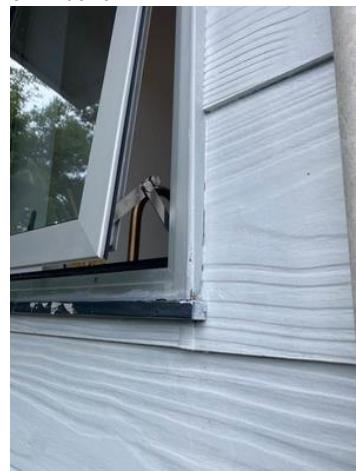
Door original. Overall average.

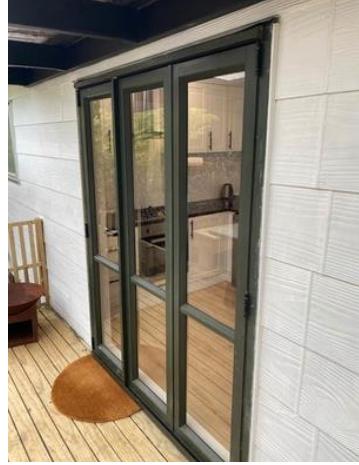
<p>Unit replaced. (Older style Joinery)</p>

Comments	<p>Overall, the joinery is in good condition for the age of the home.</p> <p>There are some remedial items which need attention as well as ongoing, regular maintenance.</p> <p>Older style of aluminium joinery is known to fail in the mitred corners, which can allow moisture ingress. Recommend ensuring these areas are well sealed.</p> <p>Cracked or missing sealant around windows is a known cause of water ingress. It is recommended that these areas are re-sealed where required monitored in future for cracking.</p> <p>Ongoing maintenance required.</p>

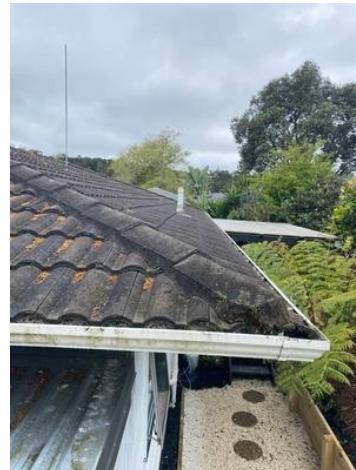
Cracked and missing pointing.

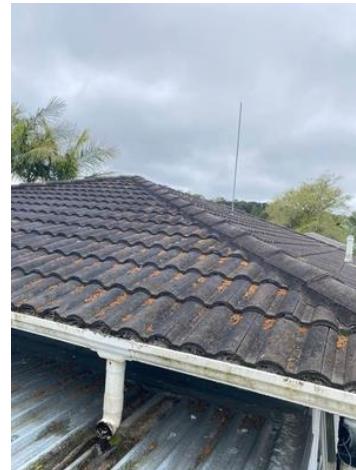
Large amount of debris to roof.

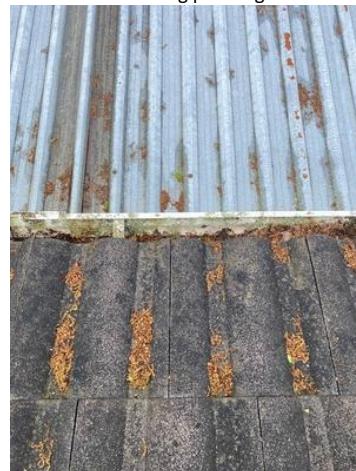
Chipped tile.

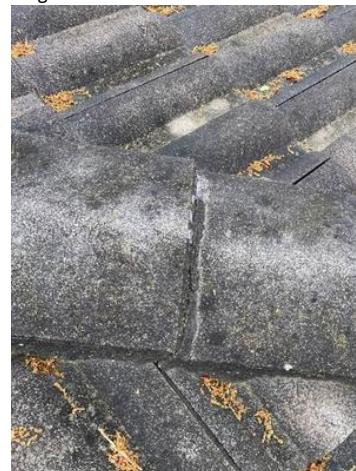
Missing pointing.

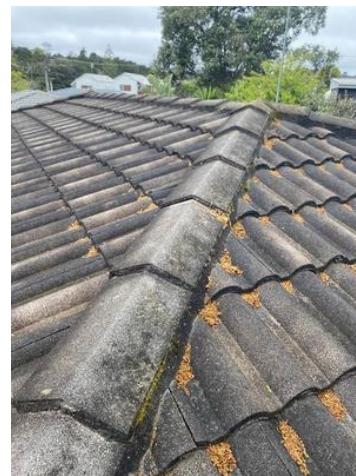
Cracked and missing pointing.

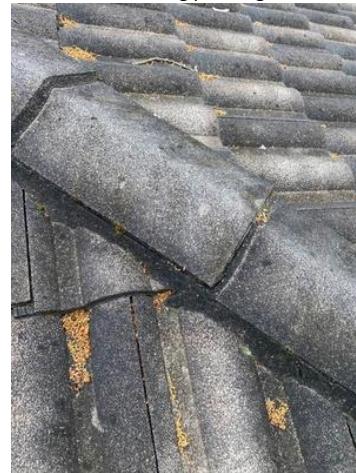
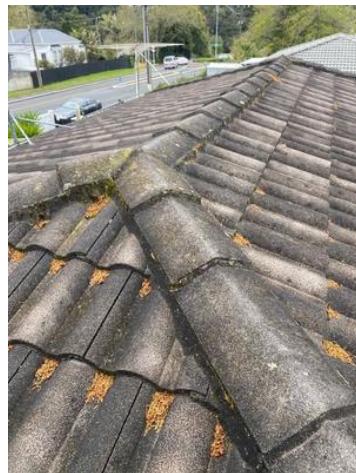
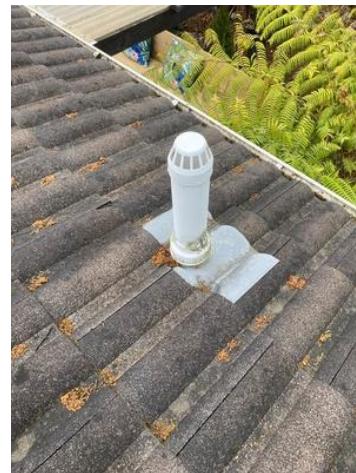
Flashing average.

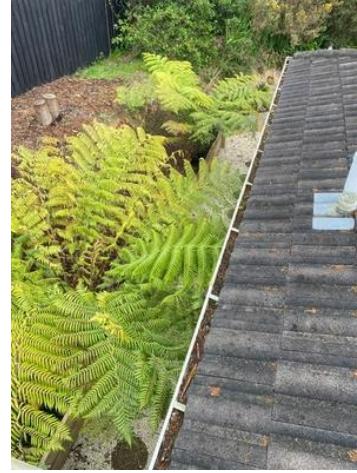
Gutter requires cleaning.

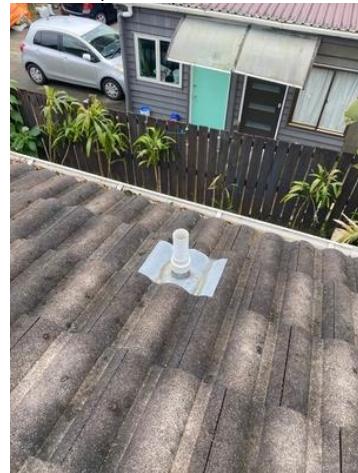
No cover to vent.

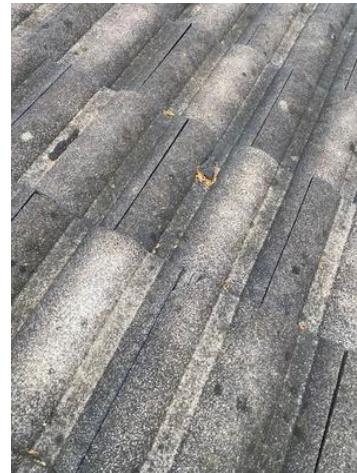
Chipped tile.

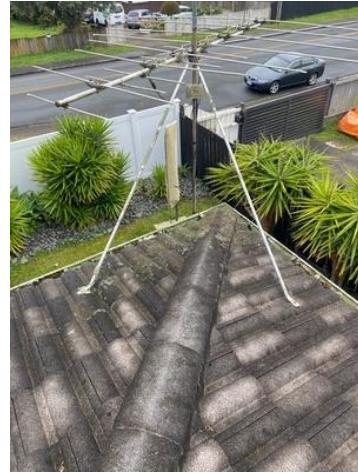
Roof dirty to this area.

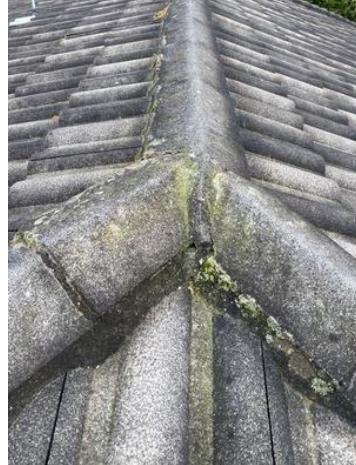
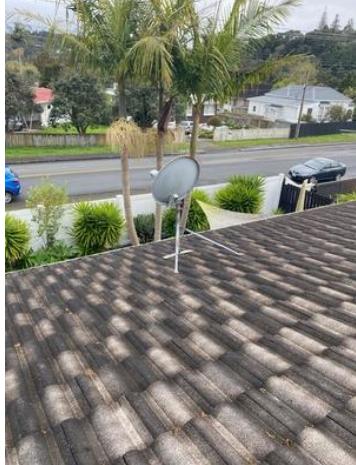
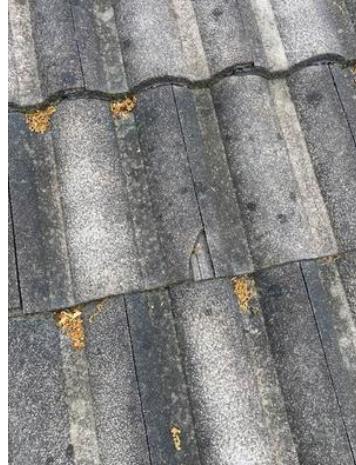
<p>Chipped tile.</p>
Comments		<p>Overall, the roof is in a condition reflective of the age of the home and a lack of maintenance for a prolonged period of time and requires attention.</p> <p>Cracked tiles and silicone repairs as noted.</p> <p>Recommend contacting a licensed roofer/roof coating expert for advice/remedial action.</p> <p>Gutters require cleaning. Regular maintenance is required to ensure gutters are free of debris and ensure that water falls the correct way.</p> <p>Roof leak to area in lounge. This appears to be around the Sky dish.</p>

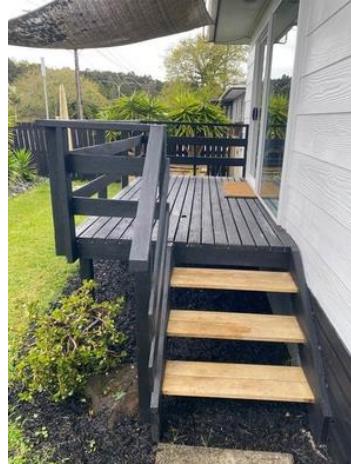
<p>Deck and stairs average.</p> </div> <div style="text-align: center;">

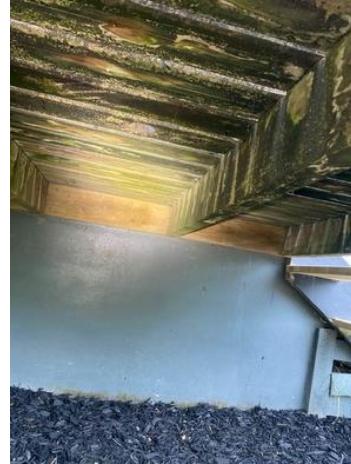
<p>No joist hangers. Recommend installing.</p> </div> </div>

No gutter to roof.
Comments	<p>Overall, the deck is in good condition for the age of the home.</p> <p>Recommend installing additional hardware to front deck. Hardware under the deck should be stainless steel. Structures directly fixed to claddings are known causes of moisture ingress.</p> <p>Recommend installing gutter to pergola to help reduce dampness to ground under the house.</p>

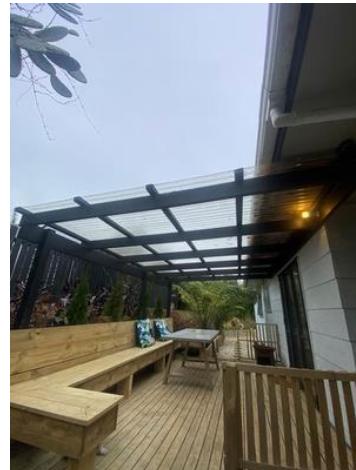
Pergola generally reasonable.

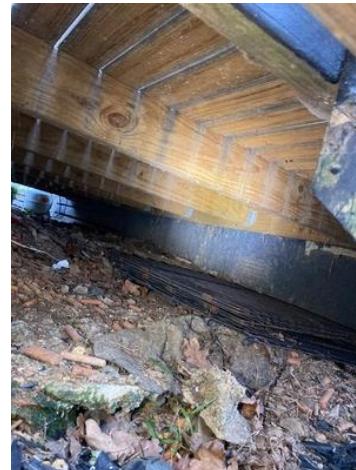
Structure appears reasonable.

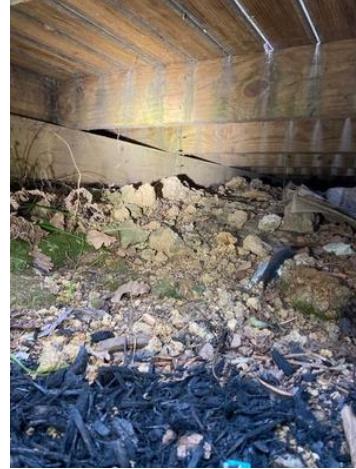
Bearer in contact with ground. Incorrect treatment.

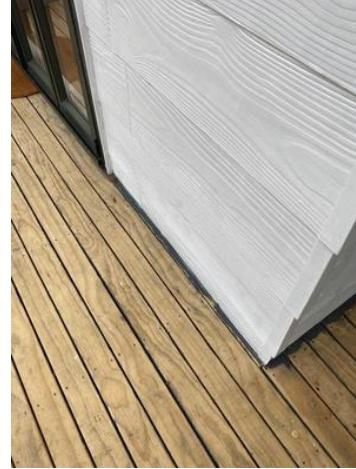
Deck in contact with cladding.

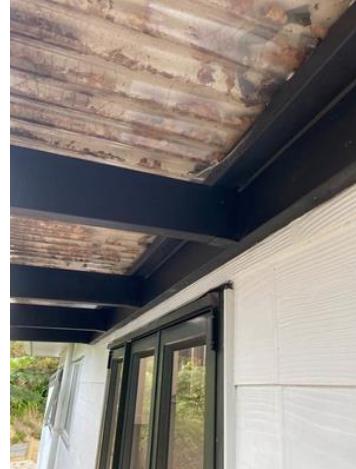
Pergola directly fixed to building.

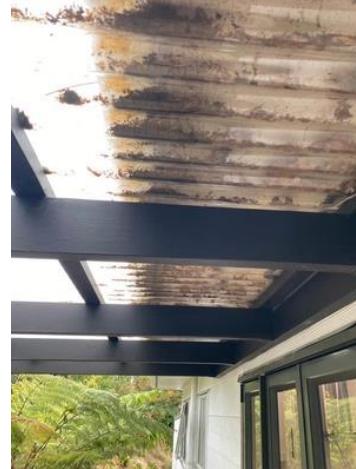
Build up of debris to this area.

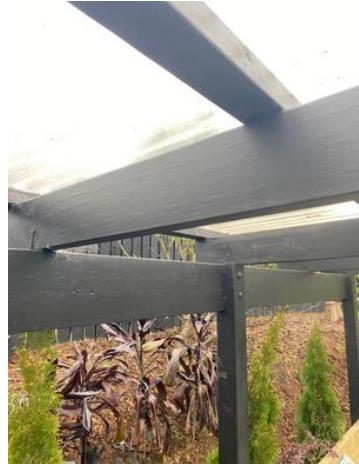
Uplift connections visible.

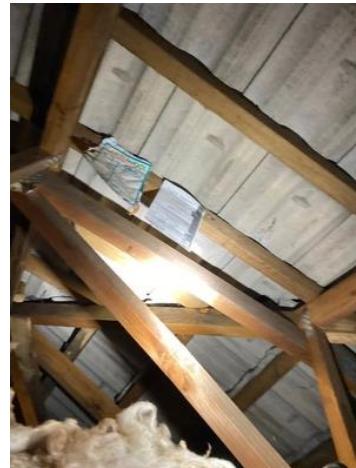
Insulation meets current standards.

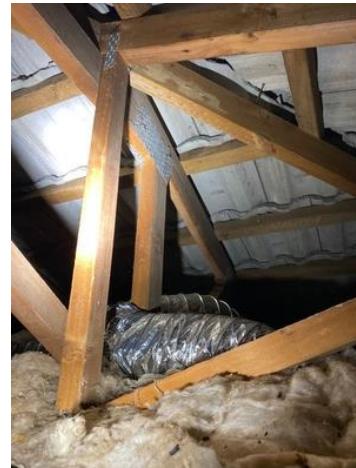
Structure appears good.

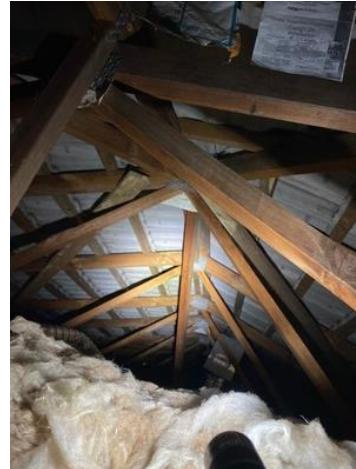
No paper under roof.

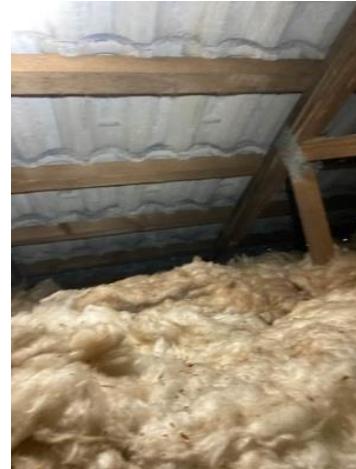
Insulation has a good, snug fit.

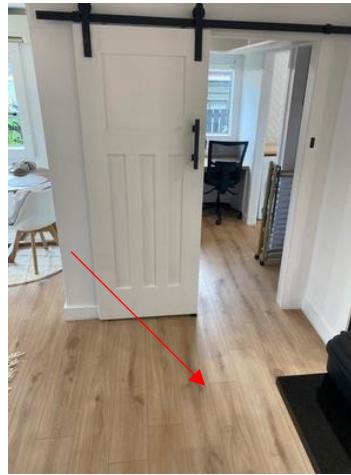
Floor significantly out of level to this area.

Floor significantly out of level indicating movement in the foundation. Recommend contacting LBP/foundations repair specialist for advice and remedial action.

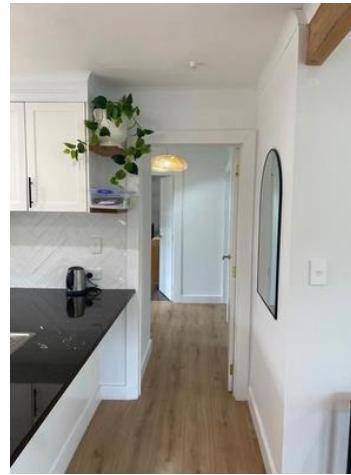
Door frame out of level.

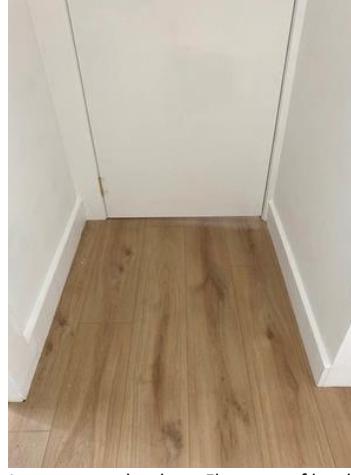
Large gap under door. Floor out of level.

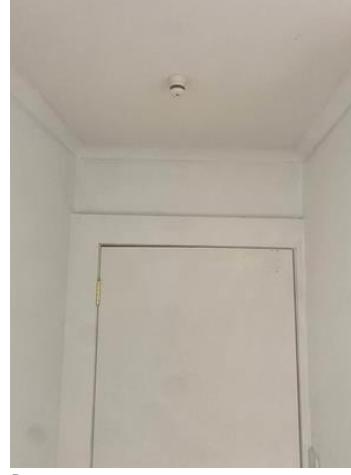
Door gap uneven.

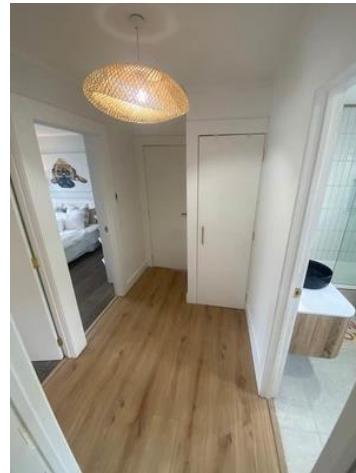
Significant unevenness to the floor to this area.

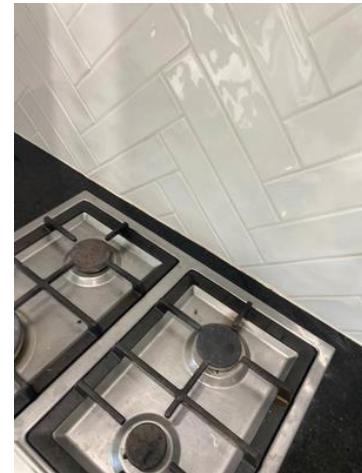
Well sealed.

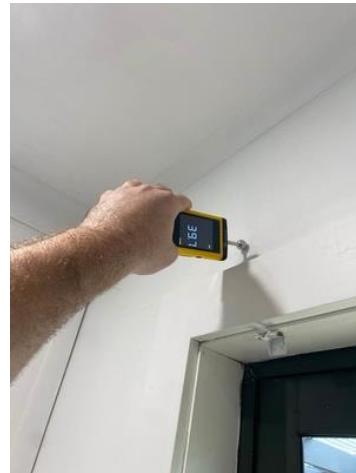
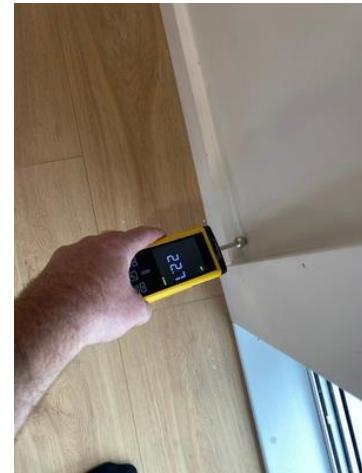
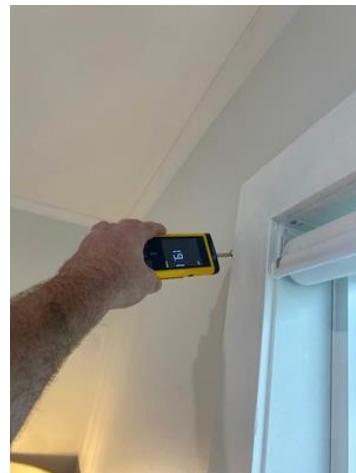
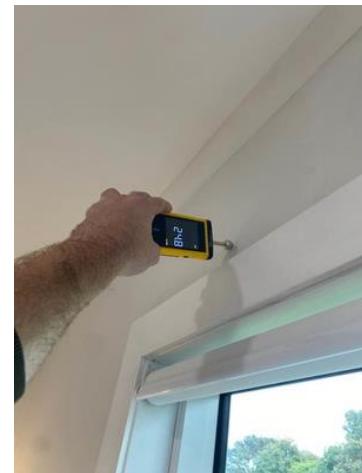
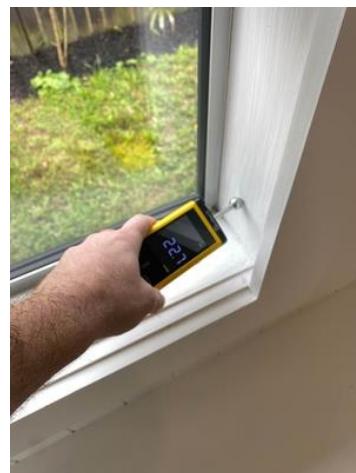
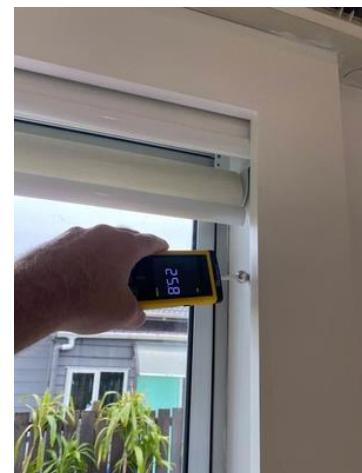
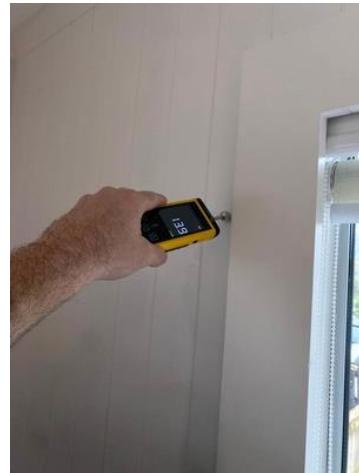
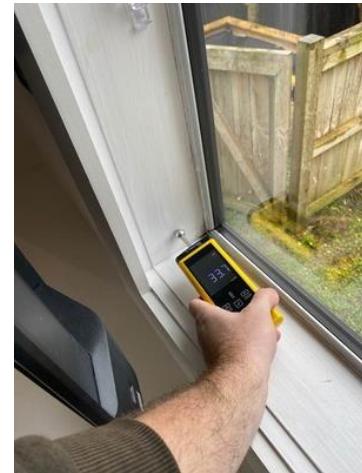
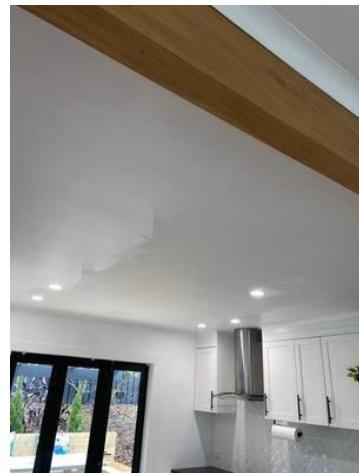
Repairs to ceiling.

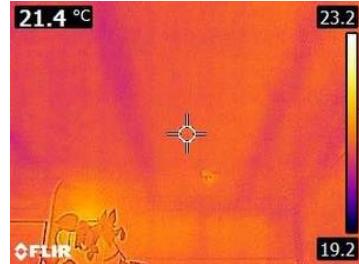
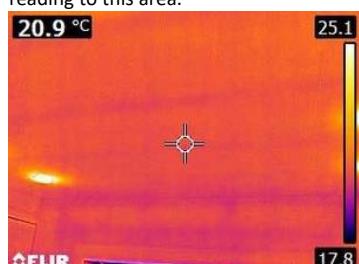
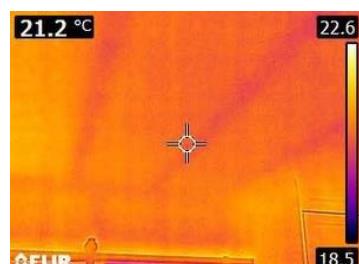
High moisture readings.

Elevated moisture reading to area as noted. Recommend further investigation.

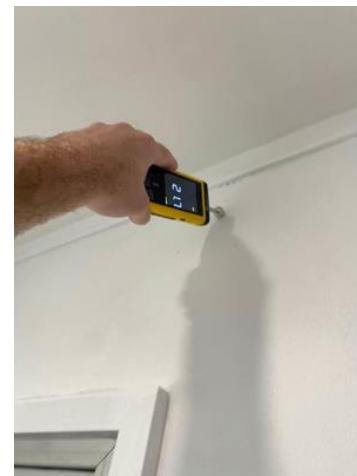
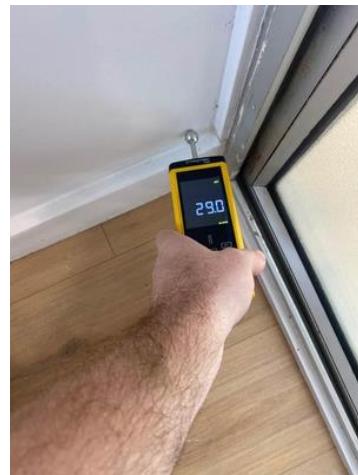
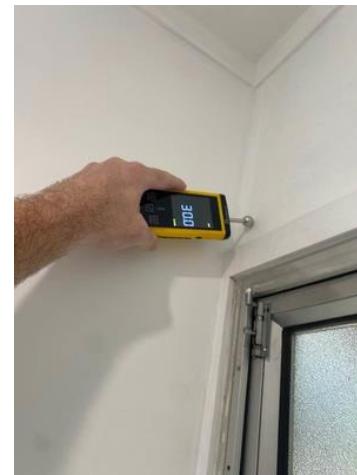
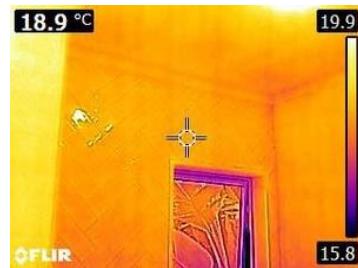
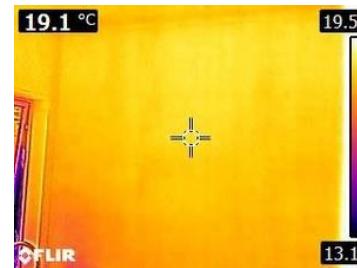
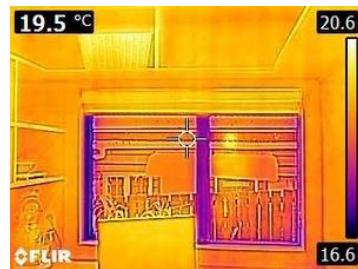
Elevated moisture reading.

Comments	Elevated moisture reading to side of laundry door. Recommend further investigation.		
Bedrooms/Office			
Overall Condition	Good		
Checked for Moisture	Yes		
Photos

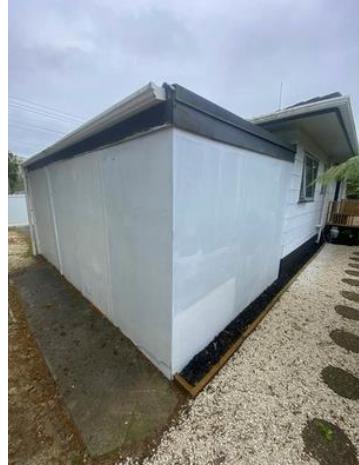
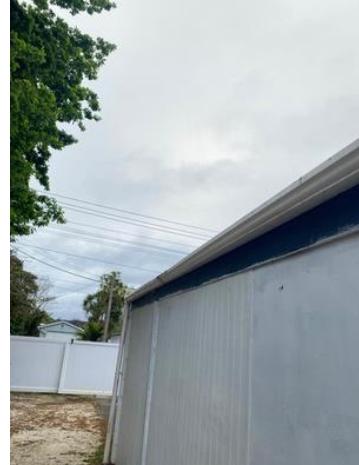
Cladding overall poor. Cladding in contact with ground. Spouting requires adjusting.

Comments	Storage shed overall average/poor. Some rot to bottom plate where visible. Gutter requires attention.
-----------------	--

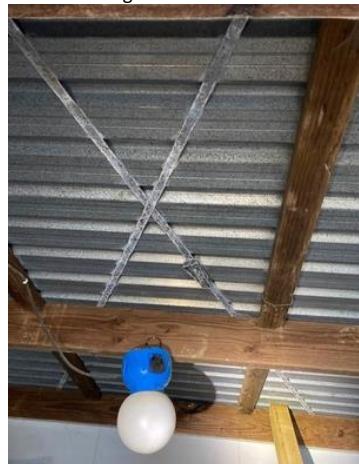
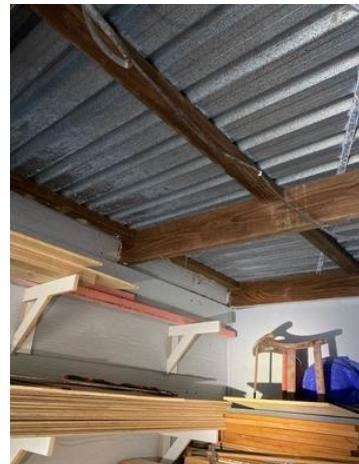
Structure appears reasonable.

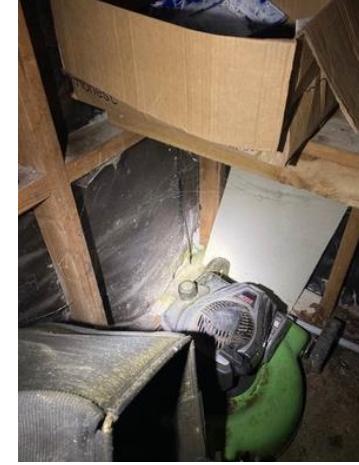
Rot to bottom plate.

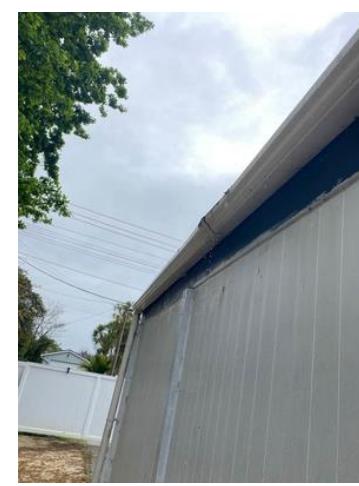
Leak to gutter.
